DOT HS 811 303

March 2010

# **Localized Fire Protection Assessment for Vehicle Compressed Hydrogen Containers**

| 7. Author(s)<br><b>Craig Webster – Powertech Labs, Inc.</b> | | | | 8. Performing Organization Report No. | |

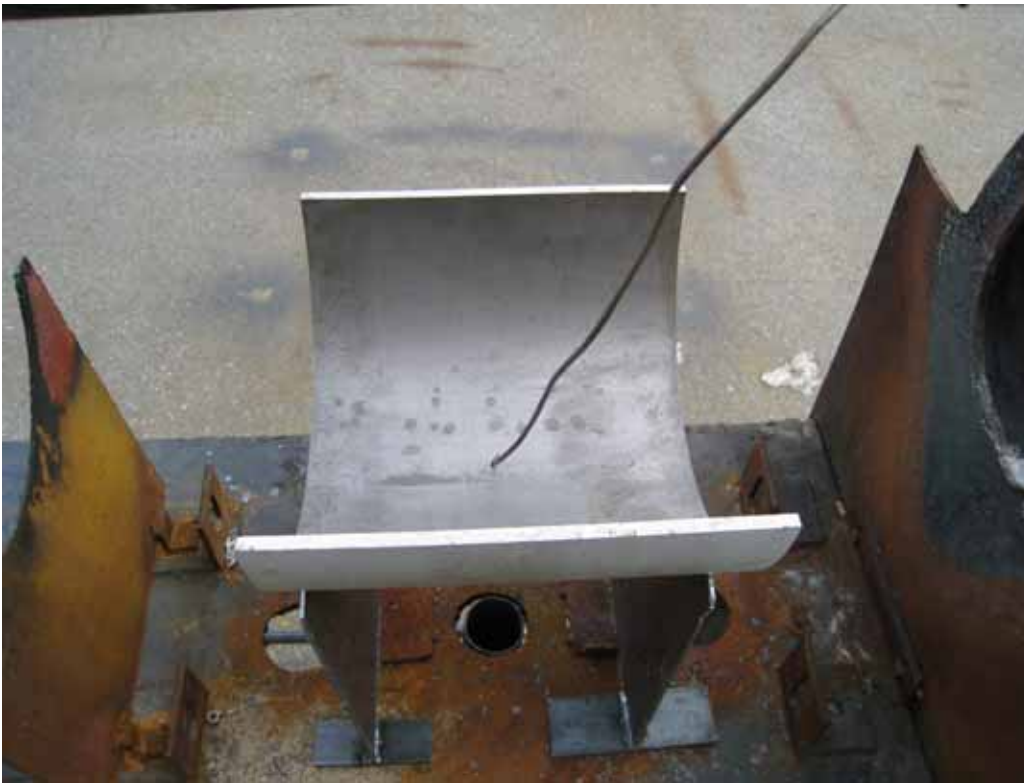
Figure 1 – Arrangement for fire testing steel pipe half-sections with one side coated by intumescent paint. Note thermocouple touching pipe surface on side opposite burner.

An intumescent flame retardant coating from PyroTech of Addison, Illinois, trade-name “PyroCide II” (an intumescent system in a water resistant polymer latex) was evaluated. Various layers were applied to steel half-pipe sections, which were then heated on the coated side while temperatures were monitored on the uncoated side (see Figures 1 and 2). Figure 3 summarizes the temperature difference generated on the inside steel surface through the use of coatings of different thickness. The results were not encouraging, since the coating would break-down and flake off after several minutes of exposure to the high temperatures used in the test. Note that these test temperatures exceeded the specifications for the coating.

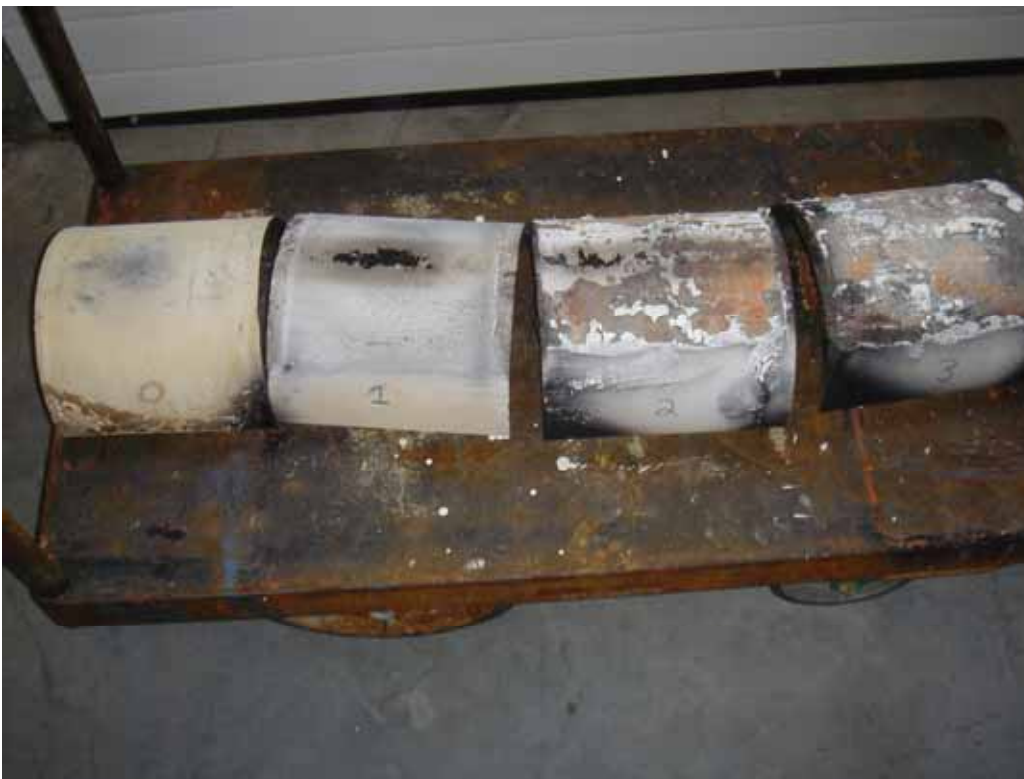
Figure 2 – Results of fire testing on PyroCide II paint coating of various thicknesses (#0 = bare steel, #3 = 3 coats of paint).

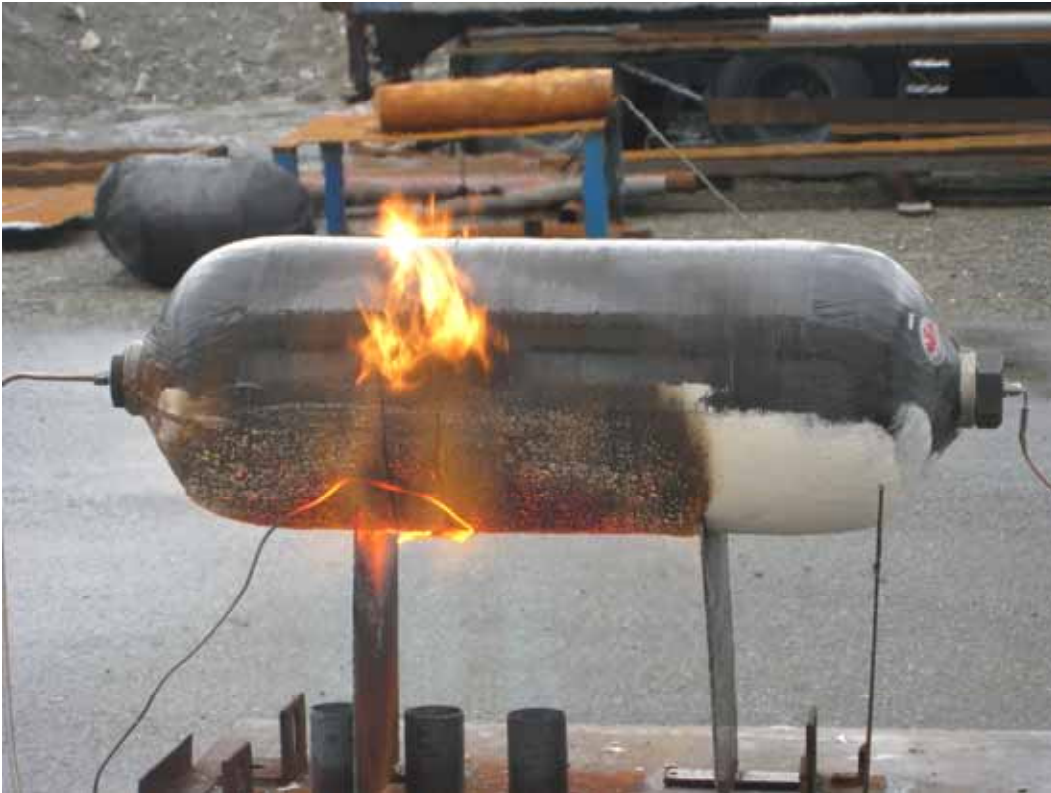
Figure 4 – Performance of PyroCide II intumescent paint coating on bottom of carbon fiber composite tank during exposure to 3-burner fire test.

A base-line fire test was conducted on an uncoated 39L carbon fiber composite tank with an aluminum liner. The 200 bar tank design was sealed at atmospheric pressure, and heated using the new fire test arrangement for 10 minutes, while the increase in internal temperature was measured. The underside of a tank of the same carbon fiber design was then painted with 4 coats of the PyroCide II coating (approximately 5 mm dry thickness), and subjected to the same test. The test is illustrated in Figure 4. Figure 5 is a graphical comparison of the results between the baseline tank and the coated tank. The data suggests that intumescent paint coatings will only offer limited protection from heat effects, especially where high flame temperatures might be encountered.

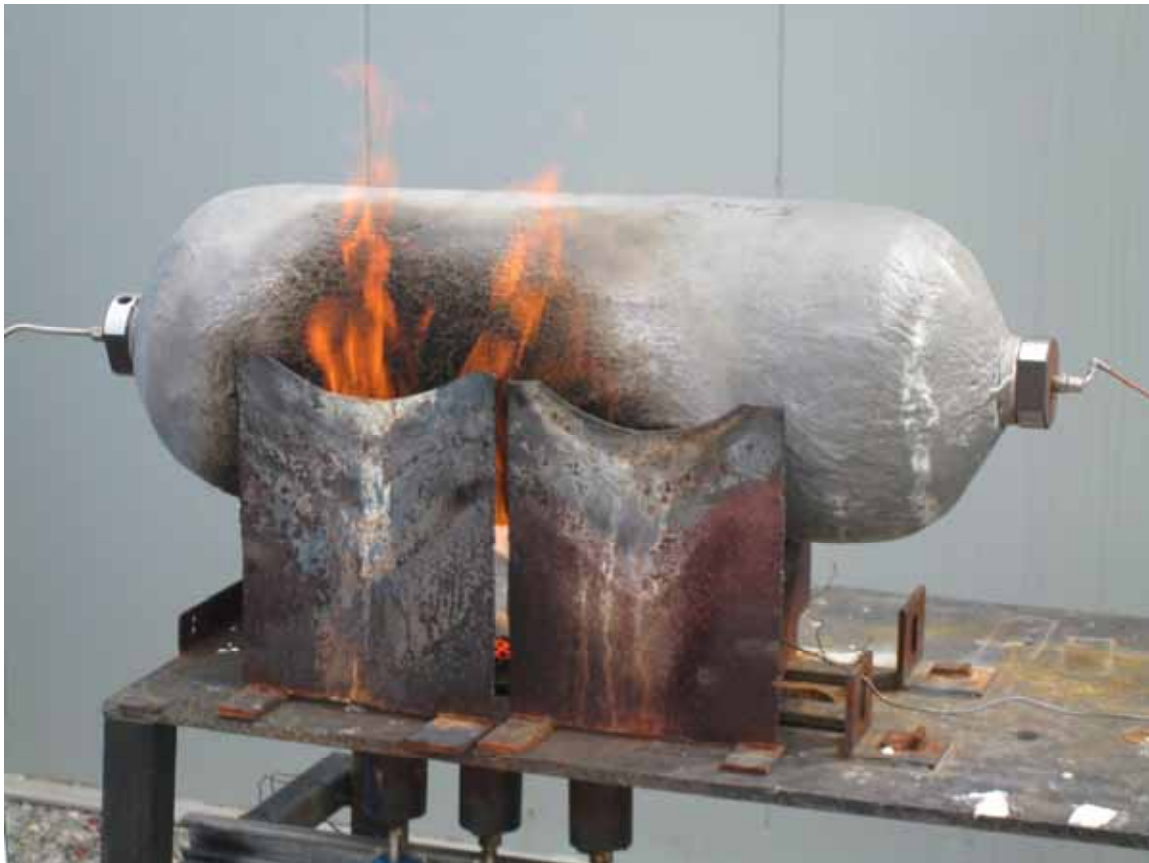
Figure 6 – Low pressure fire test of 5mm thick epoxy intumescent.

Since specialized spray application equipment is required, 4 carbon fiber tanks were sent to PPG for coating. Two tanks were coated 5 mm thick, and 2 tanks coated 8 mm thick. One tank (5 mm thick) was pressured to 7 bar with nitrogen and placed on the 3-burner unit (see Figure 6) for exposure to 800°C for 10 minutes. It was found that the intumescent expanded under heat (see Figure 7), and provided the required heat protection (see Figure 8).

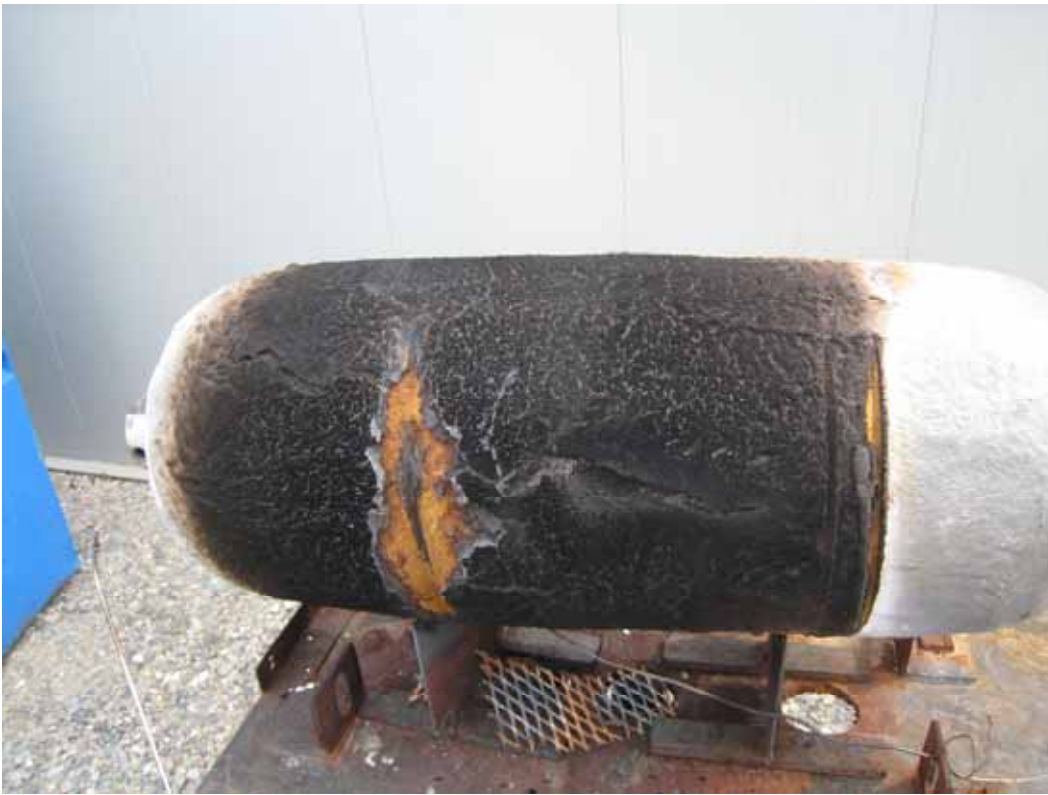
Figure 7 – Tank rotated after fire test to show foaming effect of coating. Note that the damaged area in the coating was caused by the metal support stand.

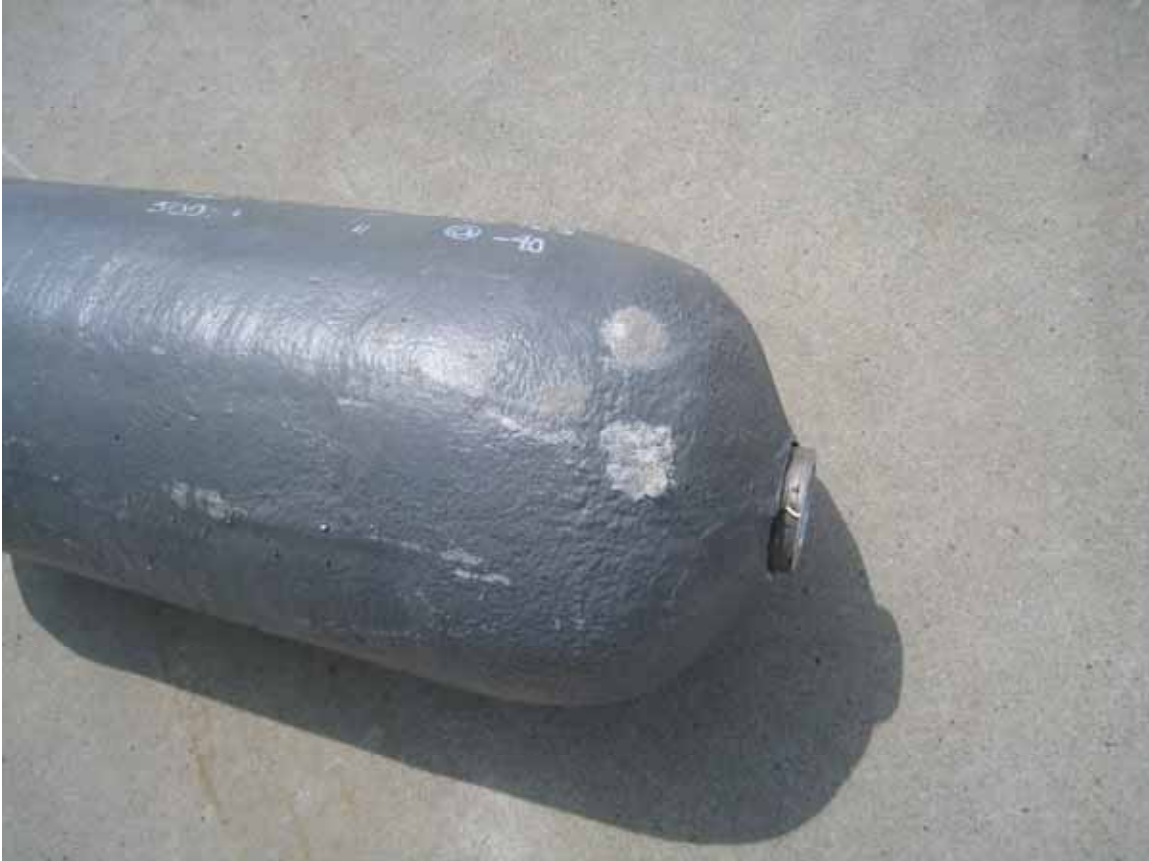
Figure 9 – Appearance of drop impact damage (rebound end) on dome end of 8 mm thick epoxy intumescent coating.

One of the two 8mm thick tanks was then subjected to performance testing, to determine if it could withstand localized impacts. The 200 bar tank was drop impacted on the dome end (2 m drop onto a concrete surface at 45 degrees from horizontal (see Figure 9), then subjected to hydraulic pressure cycling between 20 bar and 250 bar. Five hundred pressure cycles were conducted at ambient temperature, 500 hundred cycles at -40°C, and 500 cycles at +82°C. There was no apparent damage to the epoxy intumescent coating.

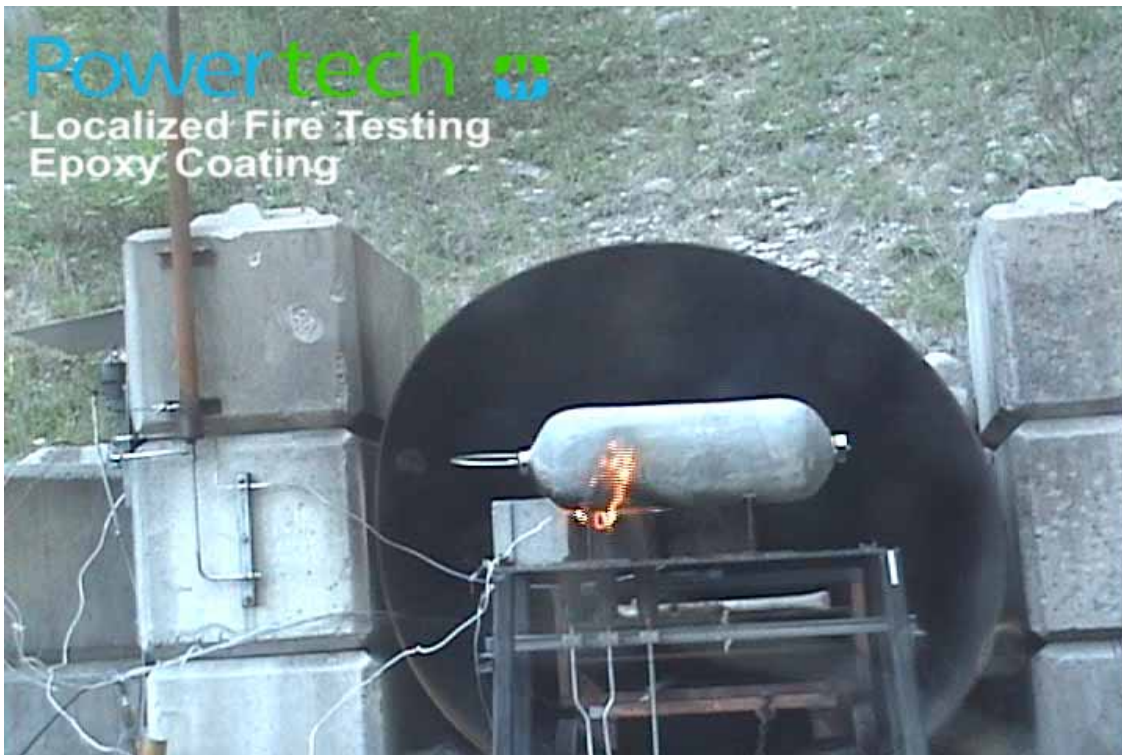
Figure 10 – Localized fire test of epoxy intumescent (8 mm thick) on carbon fiber tank containing 138 bar hydrogen for 30 minutes.

The second 8 mm thick coated tank was initially pressured to 200 bar (2,900 psi) with hydrogen, and subjected to the 3-burner test for an intended 30 minutes. During the test, there was a concern that the localized fire could burn through the protective coating and destroy the composite underneath in a very small area, causing the tank to rupture. Theoretically, if this area of damage was small enough, it could occur without any significant increase in the internal tank pressure. As a result, the tank pressure was reduced during the test to 138 bar (2,000 psi). The fire test illustrated in Figure 10, and the temperature/pressure results are provided in Figure 11. Note that after the pressure was reduced to 138 bar, some of the pressure increase observed during the test was from the chilled gas returning to ambient temperature.

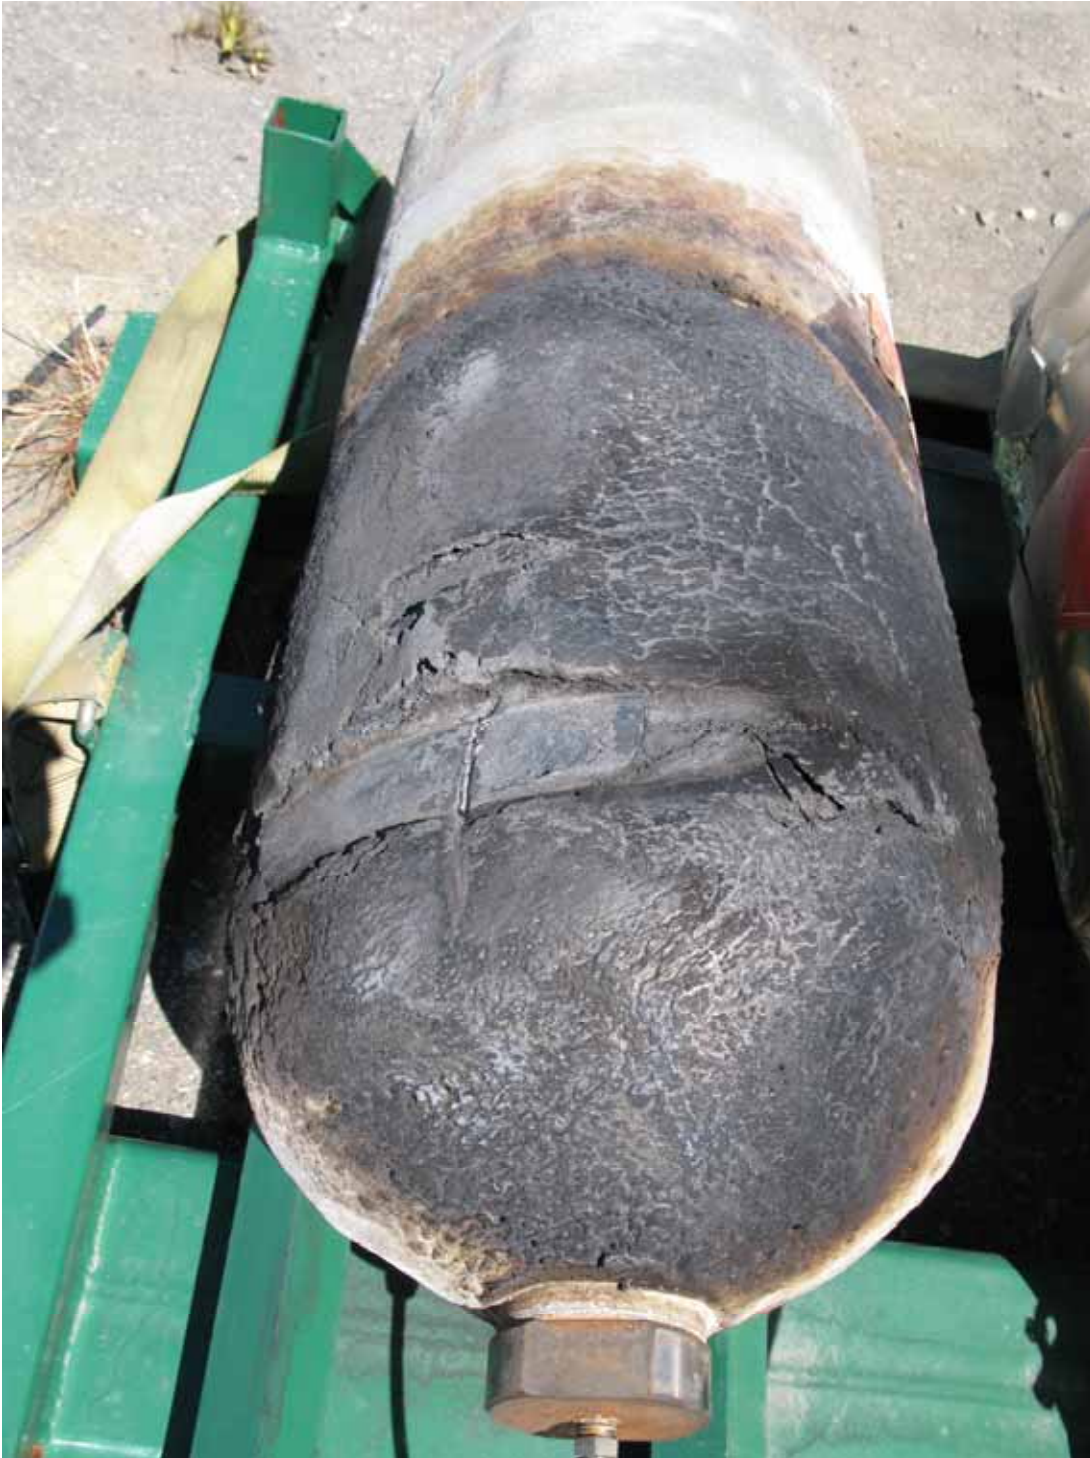
Figure 12 – Appearance of 8 mm thick epoxy intumescent coating after 30 minutes exposure to 900°C. Note that the flattened area is from handling after the test.

Upon conclusion of the test, it was observed that the intumescent epoxy was still intact, continuing to protect the carbon fiber composite from heat damage (see Figure 12). Based on the result of the 10 minute test of the 5 mm thick coating, and the 30 minute test of the 8 mm coating, it is likely that the 5 mm (or less) coating would provide adequate fire protection for a fuel tank.

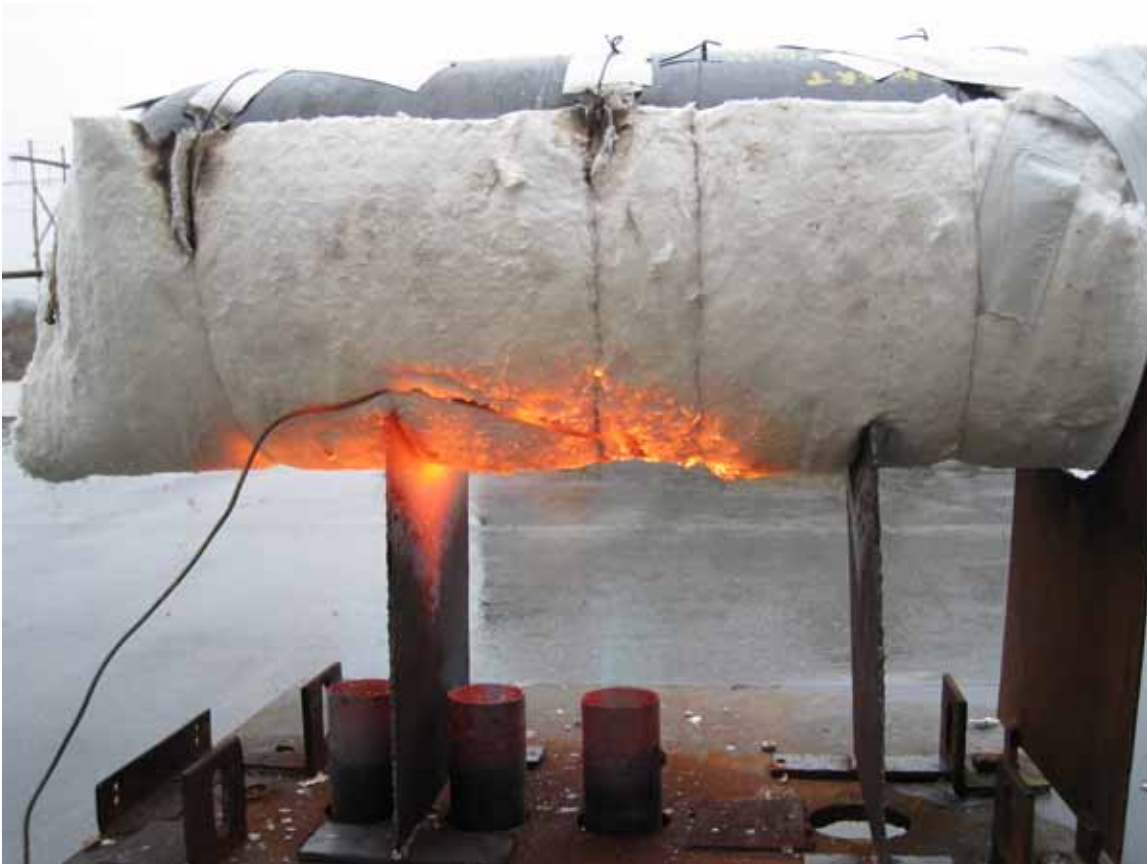
Figure 13 – Localized fire test of SuperWool 607 Plus blanket

As expected, the thick blanket provided complete insulation of the tank from the heat source. A thinner (6.5 mm) microporous blanket was also provided by Thermal Ceramics (Trade-name “Flexible Min-K”). Testing is illustrated in Figure 14, and the time and temperature plot provided in Figure 15. Again, the performance was excellent.

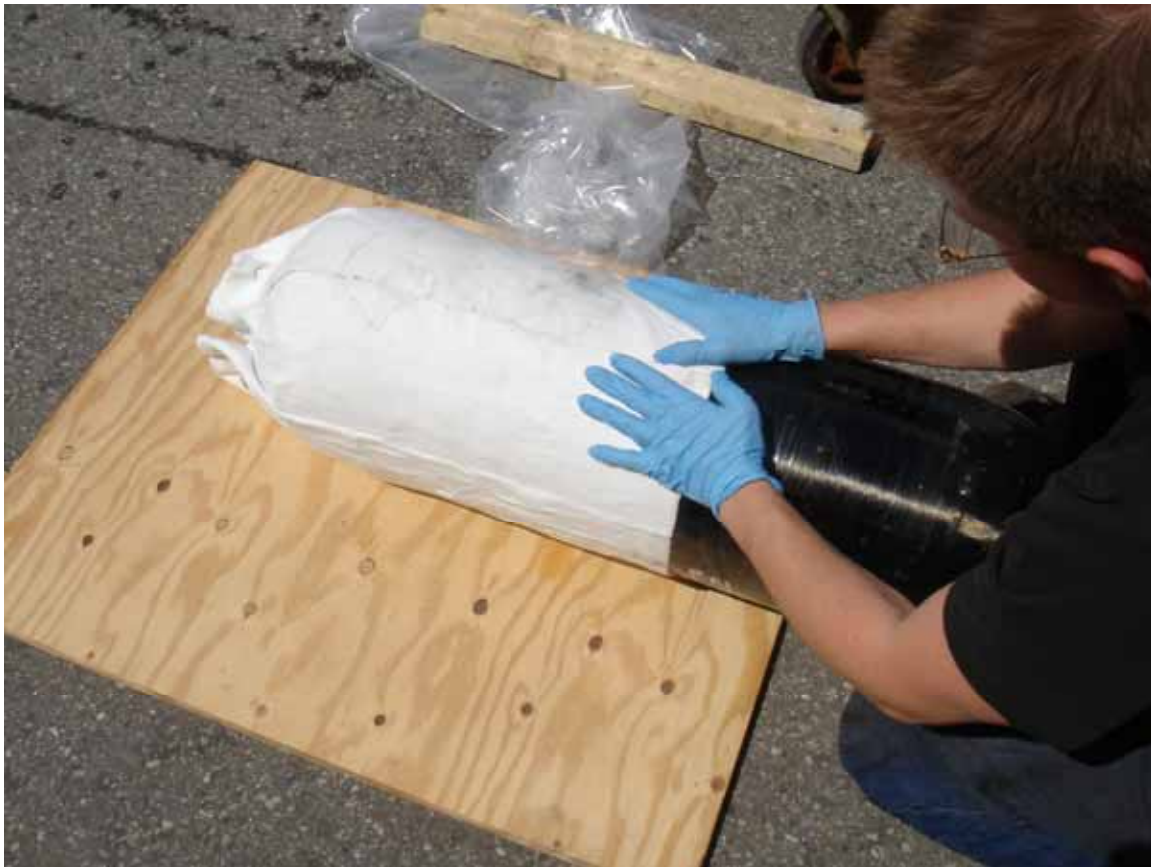
Figure 16 – Application of wet felt wrap to tank

A major concern with the use of wool wrap materials is that they must be held into place on the tank surface by some mechanical fixturing. To overcome this problem, ThermalCeramics supplied samples of another product (Trade-name I-2300 Wet Felt) that will assume the shape of the object it is wrapped around. Supplied in a wet condition, once removed from its sealed package and wrapped around a tank, it dries into place (see Figure 16). It was recommended that the dried product should be protected from damage by external cladding.

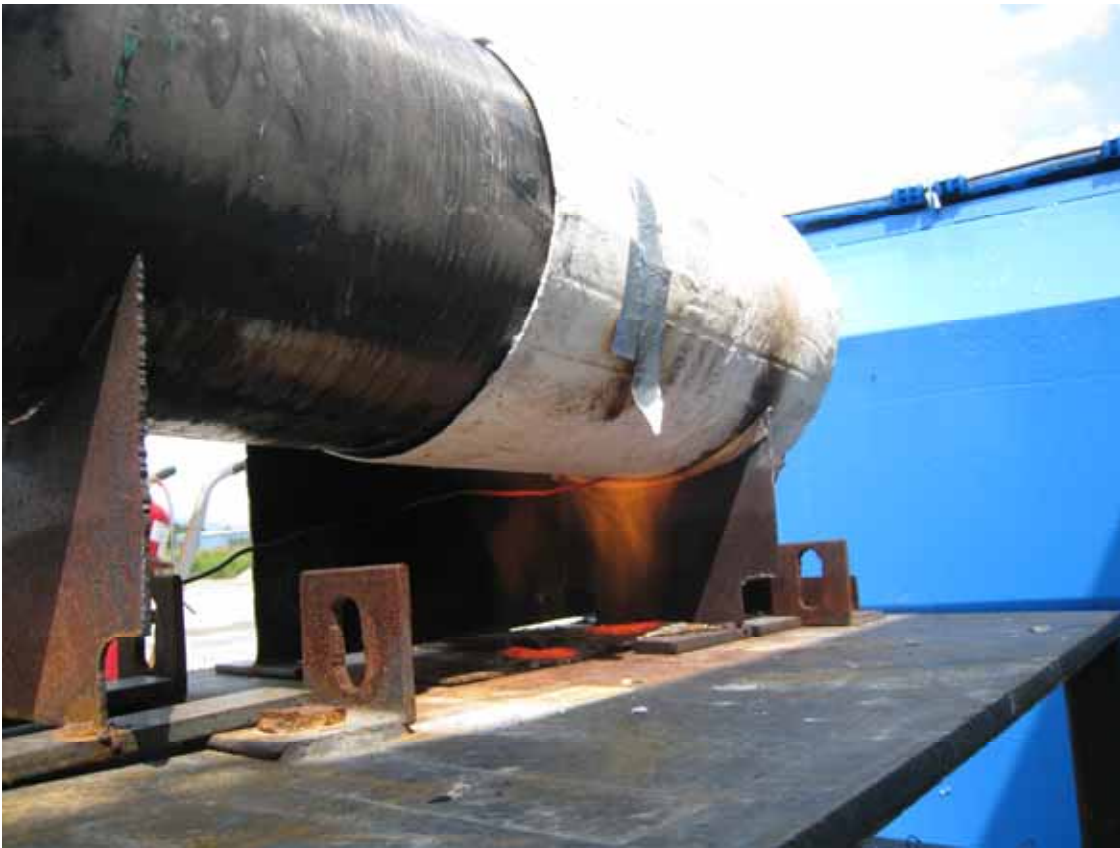
Figure 17 – Localized fire test of felt wrap after drying.

A carbon fiber type-3 composite tank wrapped on one end with the wet felt was pressured to 7 bar (100 psi) with nitrogen and subjected to the localized fire test for 5 minutes (see Figure 17). The internal pressure and temperature rise that occurred are provided in Figure 18.

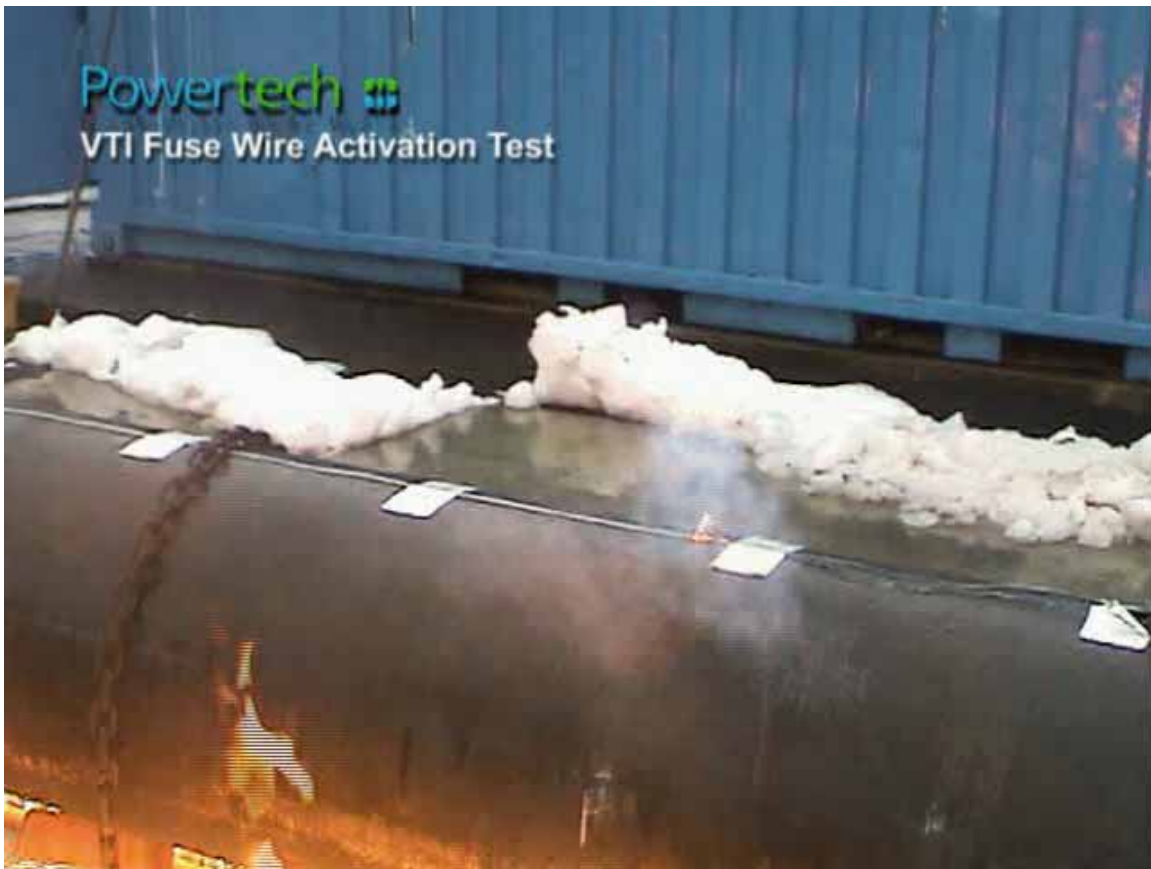
Figure 20 – Video capture from fire test of carbon fiber composite tank protected with fuse wire and TPRD at one end. Note the fuse wire burning along the top of the tank towards the TPRD (not visible in picture).

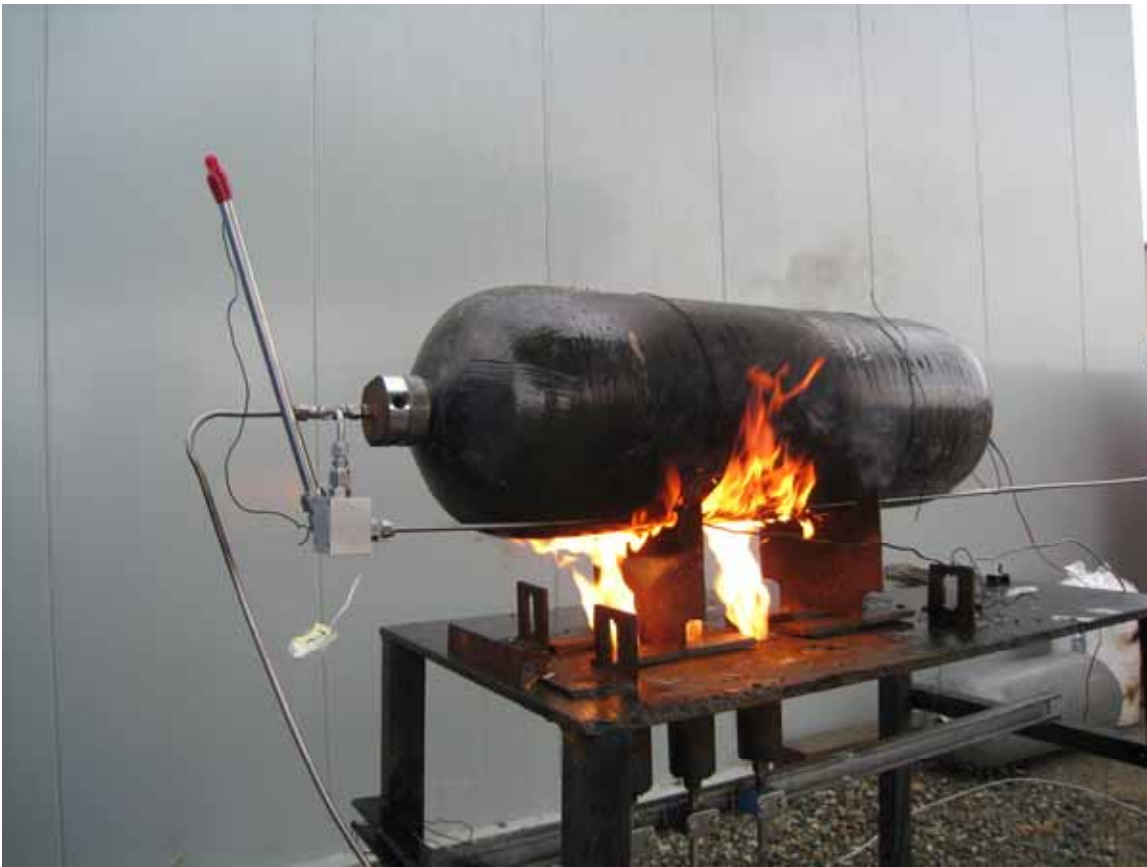
Figure 21 – Localized fire test of carbon fiber composite tank protected using a long SMA tube connected to a piston-activated PRD located outside of the fire.

Another promising heat detection technology is the use of a shape memory alloy (SMA) wire retained within a tube. When a small portion of the tube is heated (around 300mm), the SMA wire within contracts, and pulls open a piston in the pressure relief device, releasing the tank pressure. The SMA wire used in this device shrinks roughly 5% when heated to 108°C. The SMA can be placed in a tube up to 2.4m long, and can therefore protect along the entire length of tanks up to 2.4m in length. An example of a localized fire test of the device is provided in Figure 21.

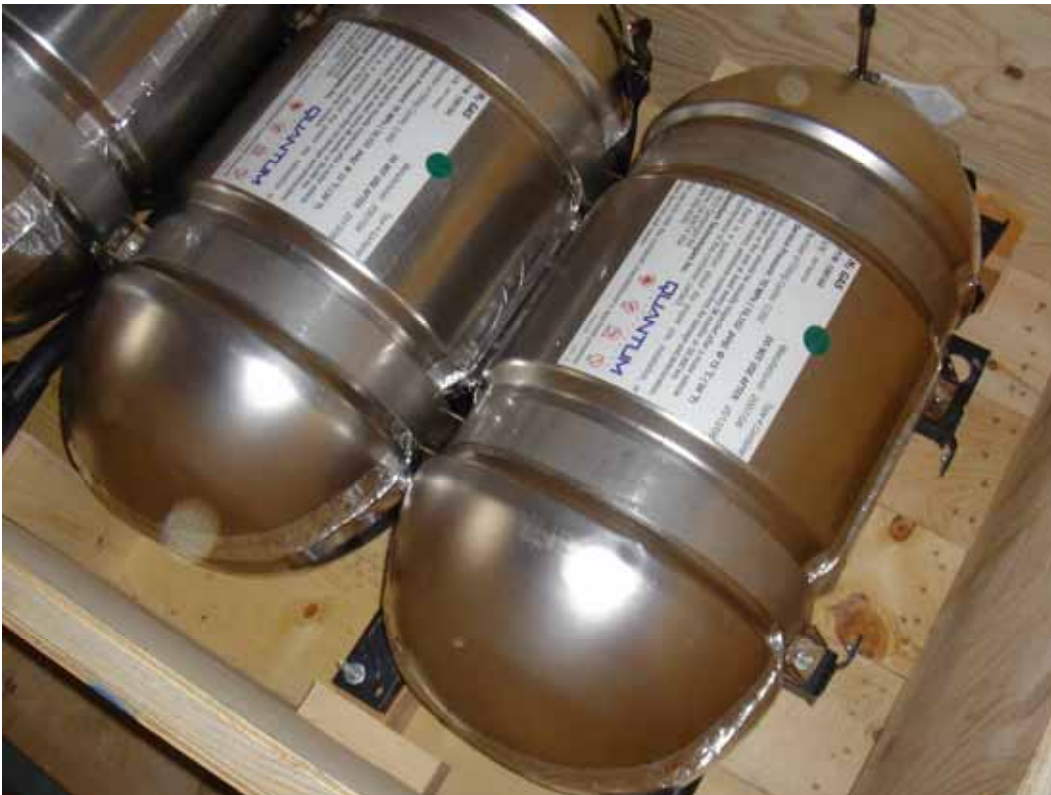
Figure 22 – Quantum fuel system assembly, complete with stainless steel shell covering.

A 700 bar hydrogen fuel storage system, complete with a manufacturer's proprietary fire protection system, was obtained from Quantum Technologies (see Figure 22). The Type 4 tanks were covered in a thin stainless steel shell of 0.635mm (0.025 inch) thickness. Within the stainless steel shell were pads of a ceramic blanket material of 12.5mm thickness separating the tank surface from the shell. The shell covering the approximate 35L (water volume) tank has a weight of 4.55 kg.

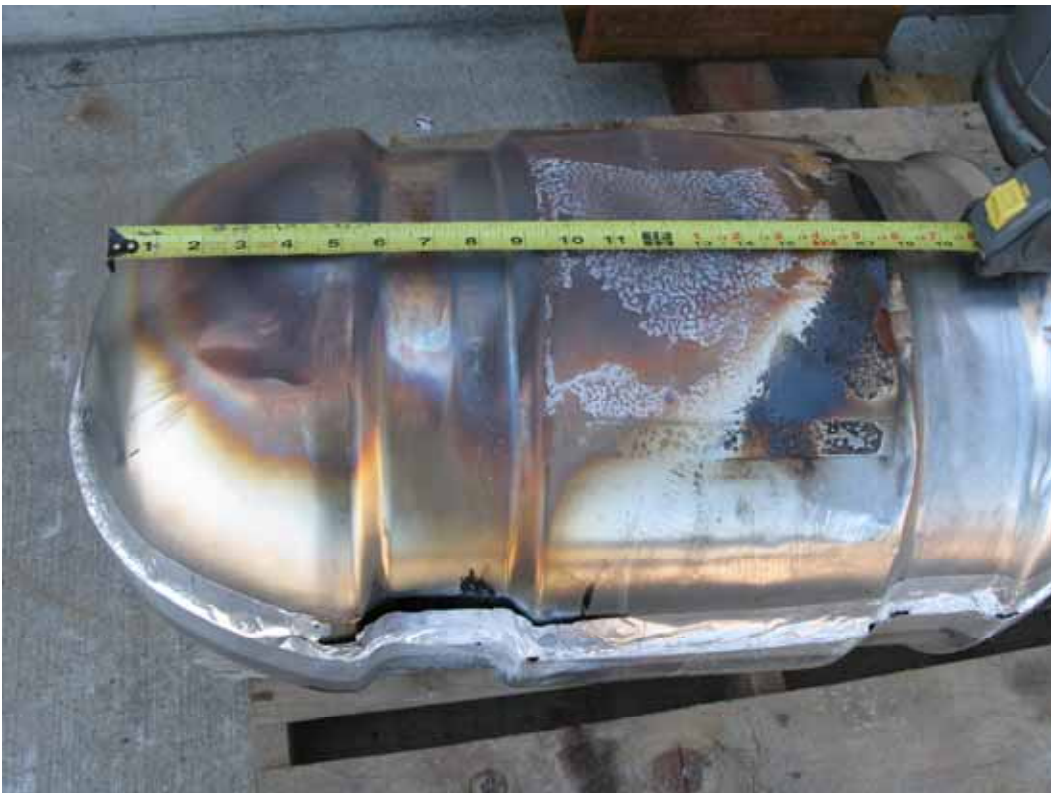
Figure 23 – Heat damage to stainless steel shell. Note that the length of the burn area is approximately 0.45 m.

One tank was removed from the assembly, filled to 7 bar with compressed nitrogen, and subjected to a localized fire test. The resulting heat damage is illustrated in Figure 23. The tank temperature and pressure rise data is provided in Figure 24.

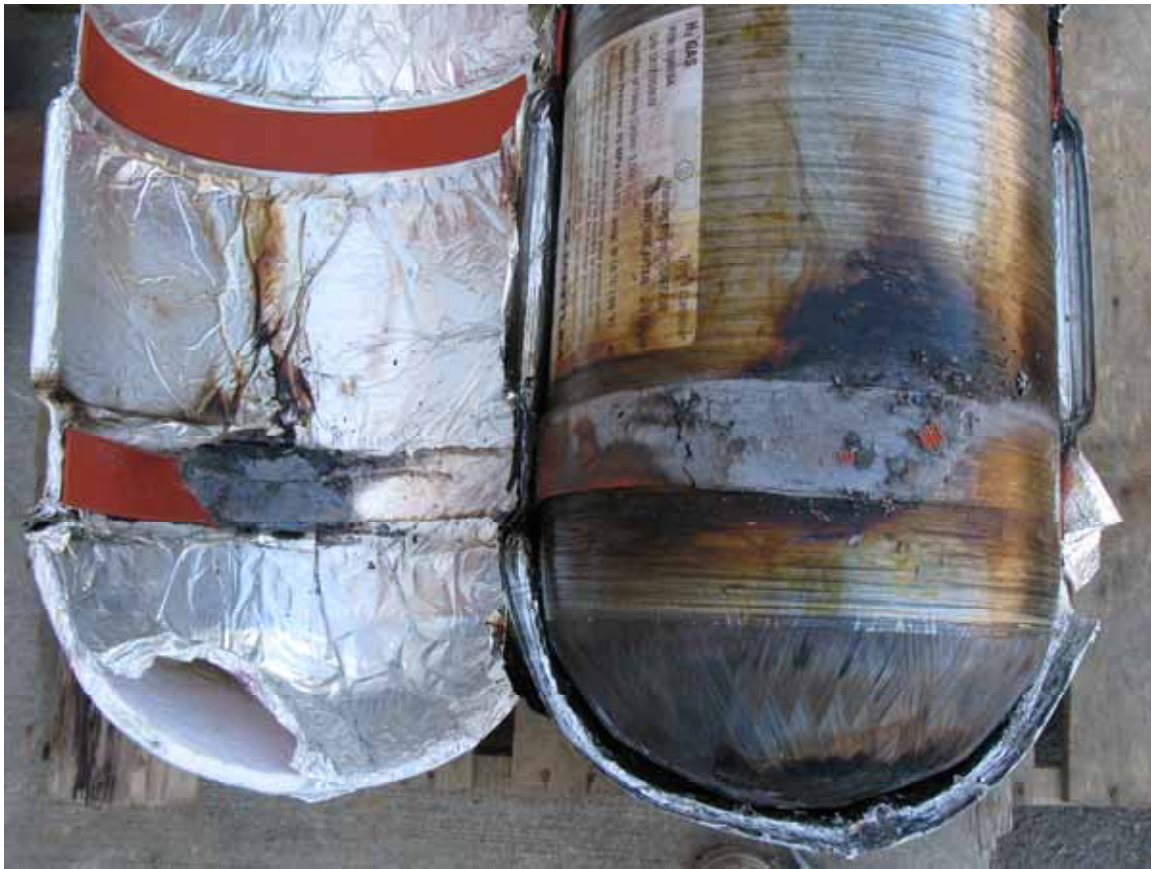
Figure 25 – Heat damage to surface of composite tank (right) revealed when heat-damaged half of shell folded open. Note the white ceramic blanket material exposed under the aluminum foil wrap (left).

The construction of the tank shell is illustrated in Figure 25. Aluminum foil is used to hold the white ceramic blankets in place. The ceramic blanket material is only placed on the end domes and the mid-wall portion of the sidewall. At the location of the assembly strapping, the only separation between the shell and the composite tank surface is a rubber strap. This strapping area also happened to be at the centre of the localized heat source. It is interesting to note that while a portion of the rubber strap melted away, the heat damage on the tank was not severe, i.e. the resin matrix did not burn away. This result suggests that perhaps the stainless shell by itself, with minimal separation from the surface of the tank, may be sufficient to prevent damage from localized fires.

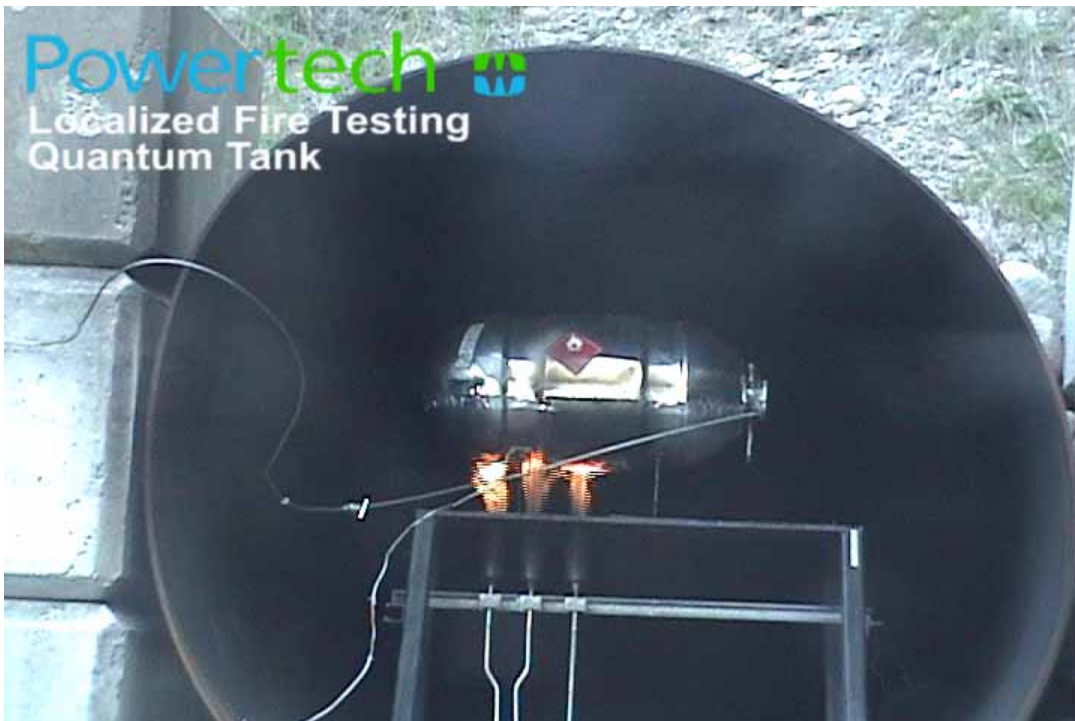
Figure 26 – Localized fire test of Quantum fuel tank containing 700 bar hydrogen for 30 minutes.

A second Quantum unit from the fuel storage system assembly was removed and pressured to 700 bar with hydrogen for field testing (see Figure 26). The tank survived the 30 minute test at localized fire temperatures of 900°C without incident. The temperature and pressure profiles are provided in Figure 27.

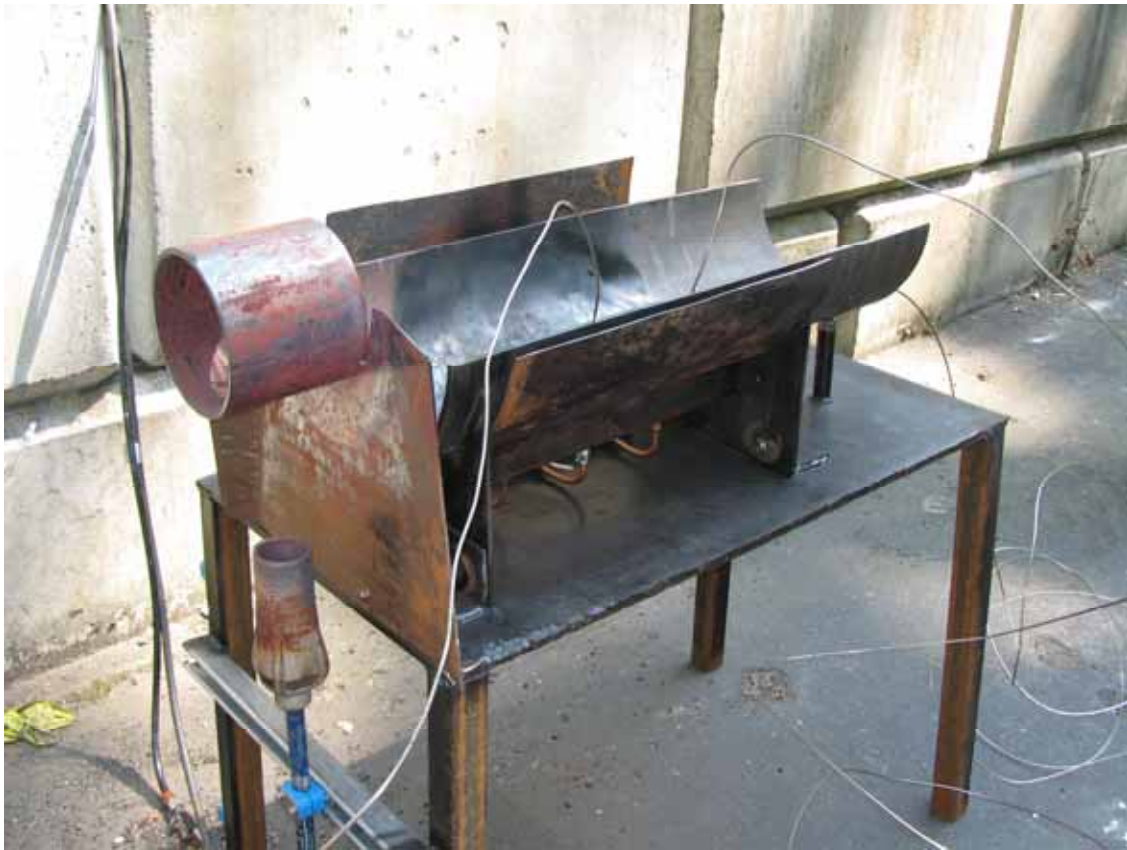
Figure 28 – Metal cradle used to generate different heat zones on a tank. In addition to burners located under the sidewall area, note the torch under the valve end.

In a previous study, in response to a specific definition of a localized fire condition involving several different heat zones on a tank, Powertech developed a “hot plate” method for testing [6]. This approach involved placing the tank on a curved metal cradle that matched its diameter (see Figures 28 and 29). By heating the metal cradle from below, it was possible to closely control the temperature on the surface of the tank.

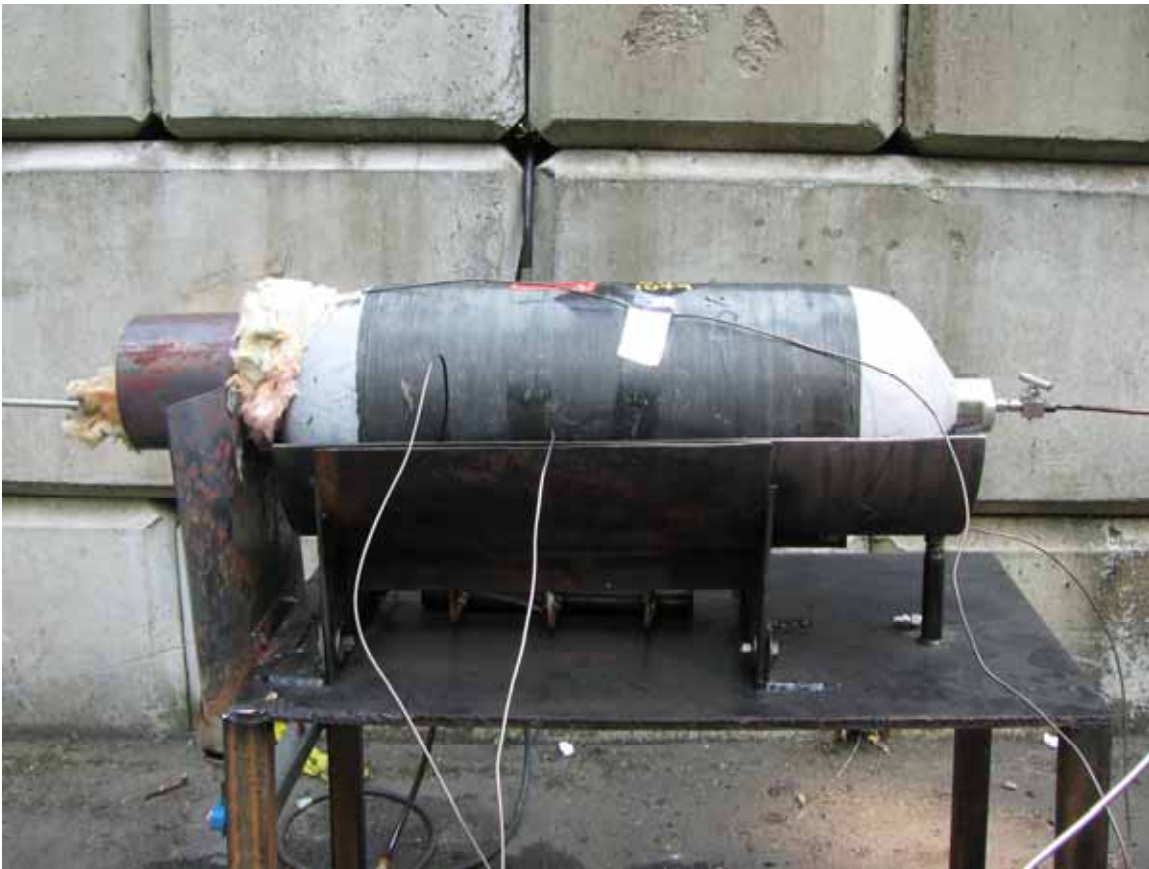
Figure 29 – Tank set-up for fire testing on the cradle.

However, during the evaluation of protective fire coating systems and heat detection systems for this project, it was concluded that the use of such a cradle apparatus was difficult. This is because the concept requires the construction of a cradle that matches the diameter of each tank tested. In addition, cradle heating may be incompatible with coating systems that expand when heated, or detection systems that are bulky and would prevent intimate contact of the tank to the cradle.
