*Presented at the ASME International Mechanical Engineering Congress and Exposition,
November 15-19, 1999, Nashville, Tennessee.*

*Published in Crashworthiness, Occupant Protection and Biomechanics in Transportation
Systems, ASME, AMD Vol. 237/BED Vol. 45, 1999.*

A Numerical Evaluation of Protection Strategies for Cab Car Crashworthiness

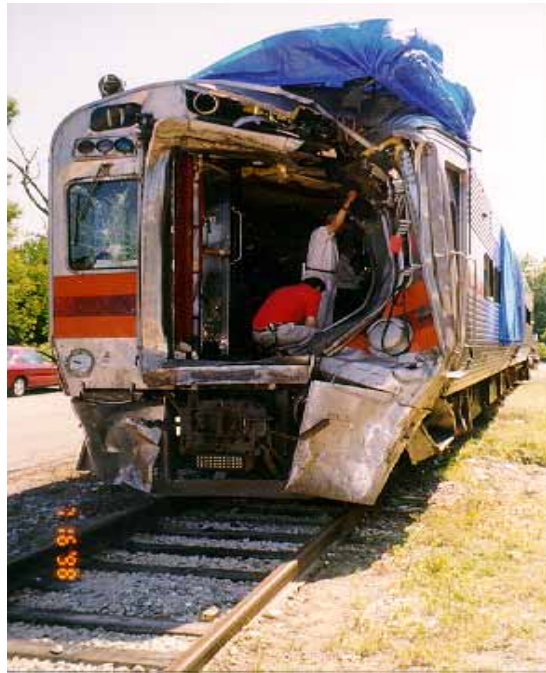
Figure 3. The front end of the cab car following the collision.

In June of 1998, a train made-up of two cab cars traveling at a speed of 57 mph collided at a grade-crossing with a flat bed truck carrying a large coil of sheet steel. The 6-foot diameter by 4-foot wide coil of sheet steel was oriented on the bed of the truck such that the collision occurred in the manner depicted schematically in Figure 2. It appears that the coil struck the cab end above the floor and offset to one side of the vehicle (Figure 3). The coil appears to have penetrated about three to four feet into the left side of the cab. The left collision post fractured just above a shear reinforcement plate. There were three fatalities from the crush and intrusion of the coil into the cab car.
