U.S. Department  
of Transportation  
**National Highway  
Traffic Safety  
Administration**

DOT HS 812 224

# **Independent Evaluation of Heavy-Truck Safety Applications Based on Vehicle-to-Vehicle and Vehicle-to-Infrastructure Communications Used in the Safety Pilot Model Deployment**

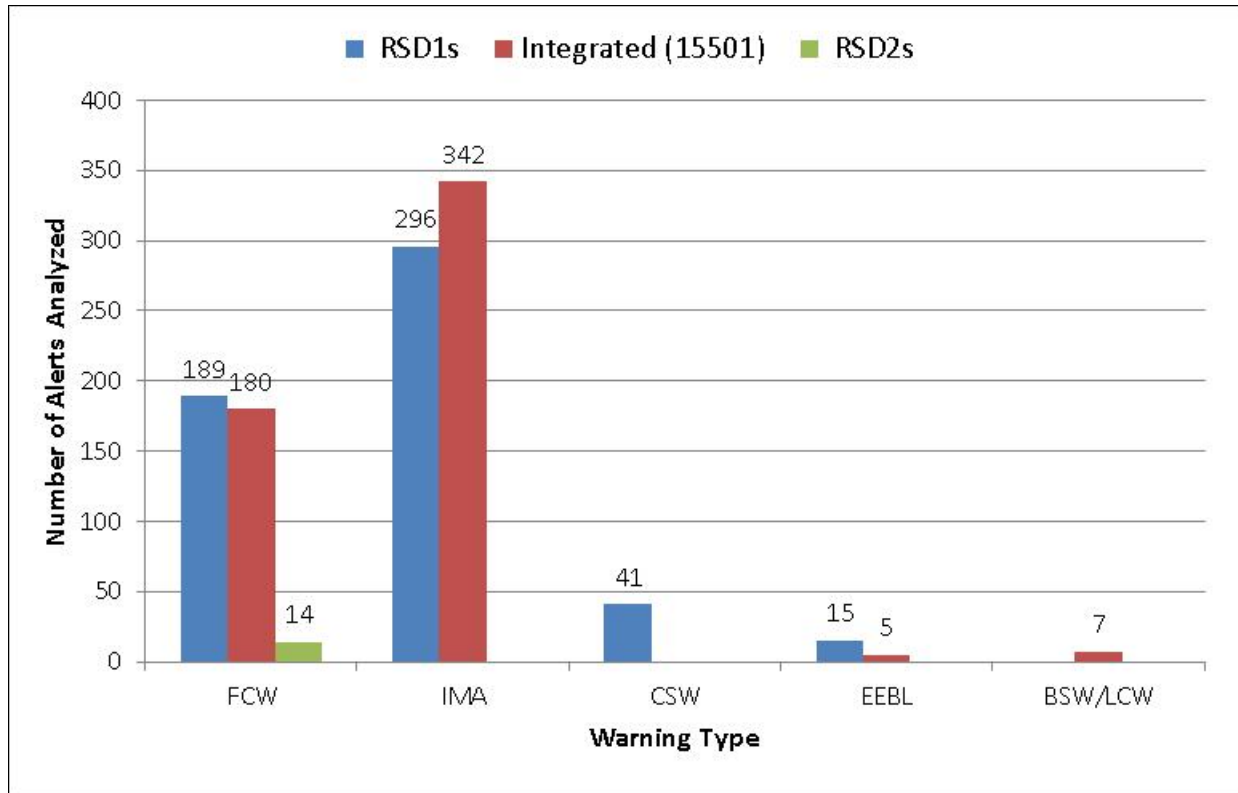
Figure 1 shows the breakdown of crash-imminent alerts by safety application. The majority of the alerts were issued for FCW and IMA. There were a small number of FCW alerts issued by the RSD2s. In addition, due to video synchronization issues with two of the three integrated trucks (devices 15101 and 15901 (see section 2.5.4)), data from only one integrated truck #15501 was used in the evaluation.

Figure 1. RSD and Integrated Truck #15501 Alerts by Safety Application

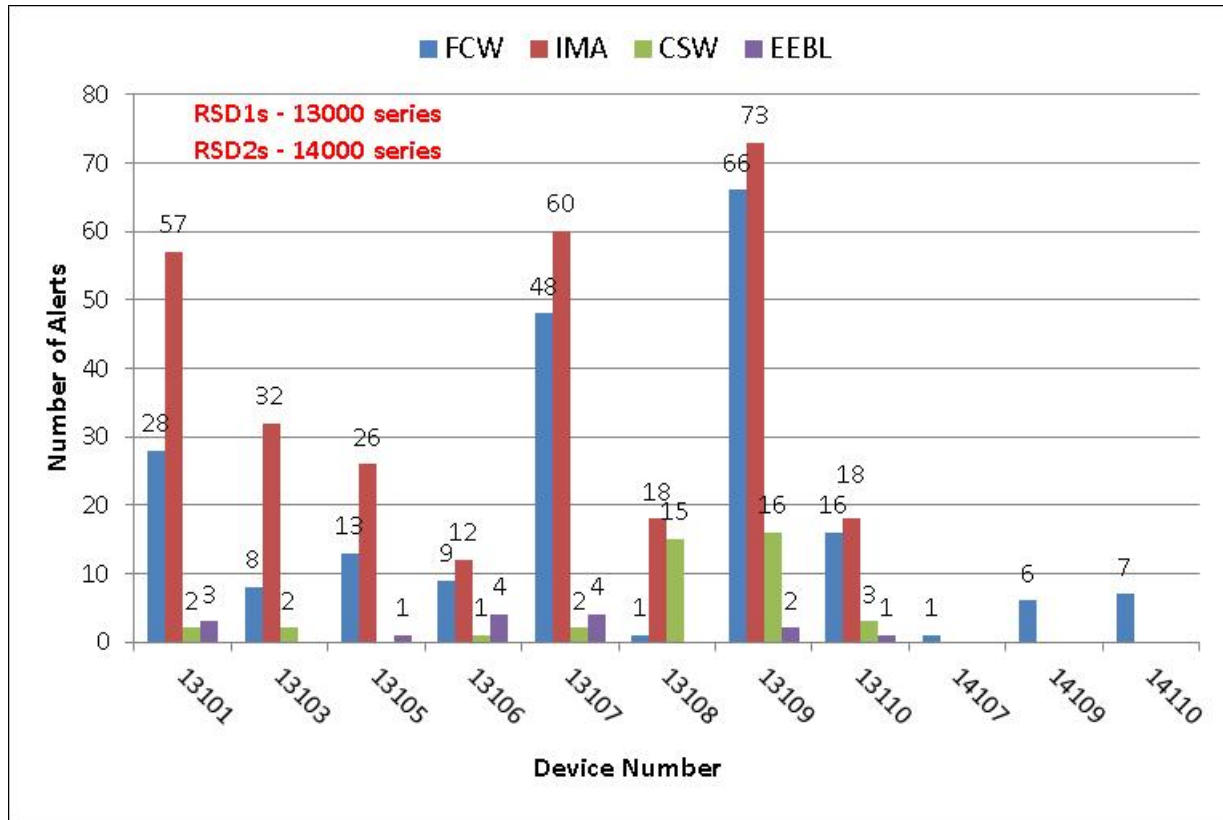
Figure 2 shows the total number of crash-imminent alerts for each RSD. The top three devices with the largest number of FCW and IMA alerts were truck #13101, truck #13107, and truck #13109.

Figure 2. Total Number of Crash-Imminent Safety Application Alerts by RSD

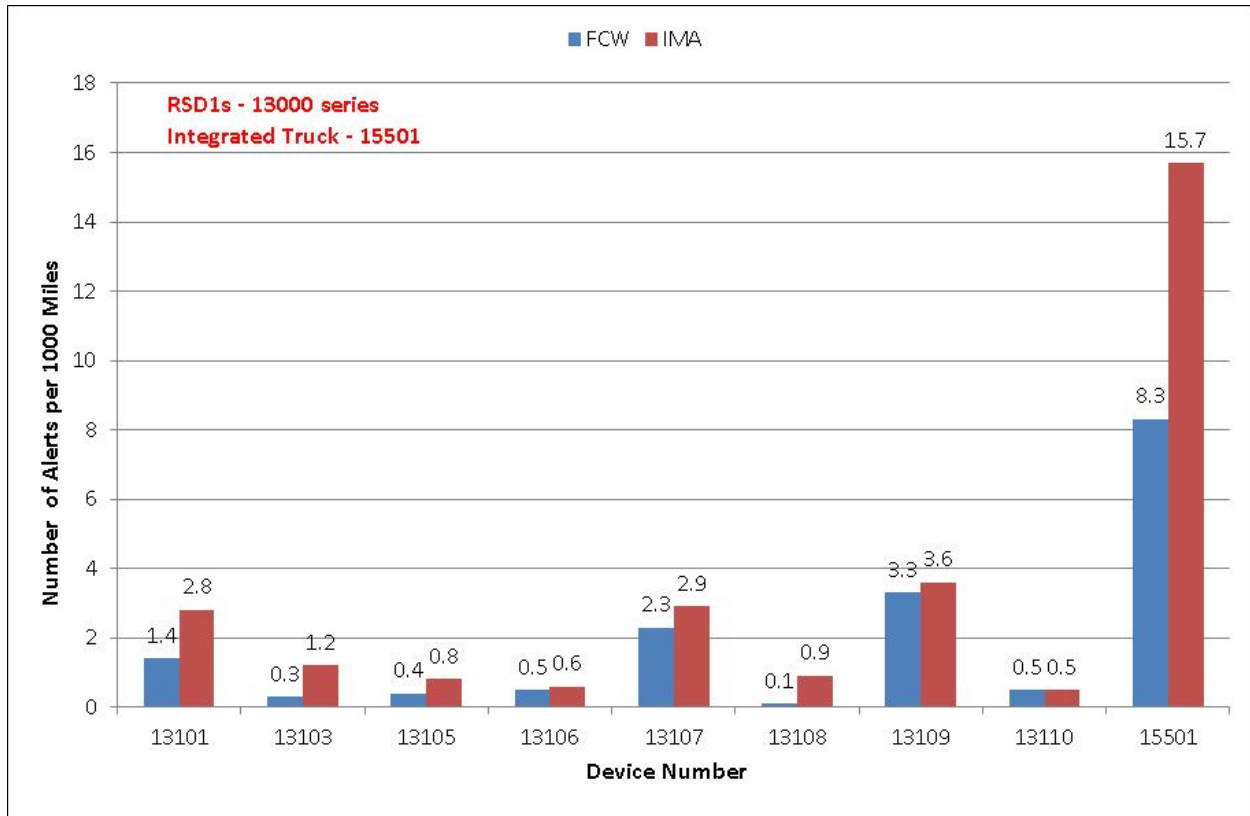
Figure 3 shows the number of FCW and IMA alerts for each RSD1 and integrated truck #15501, normalized by mileage. Due to the small number of FCW alerts issued by the RSD2s, these values are not included here. Normalizing the alerts by miles driven shows the same trend exhibited in Figure 2 (i.e., trucks #13101, #13107, and #13109 issued the most FCW and IMA alerts). The integrated truck issued the most alerts per 1000 miles driven. It should be noted that the total miles driven for each truck ranged from 20,000 to 30,000 miles. The trucks with the highest number of alerts were driven an average of 21,000 miles. The higher alert rates issued by the integrated truck #15501 could be attributed to the non-naturalistic routes driven by the UMTRI drivers. As stated previously, the UMTRI drivers were recruited to drive the three integrated trucks in the SPMD area under non-naturalistic conditions to increase the exposure of these vehicles to other similarly equipped vehicles in the SPMD area. These drivers were assigned pre-prescribed routes which were not typical routes driven by the professional truck drivers.

**Figure 3. Number of Crash-Imminent Alerts per 1000 Miles Driven for Each RSD1 and Integrated Truck #15501**

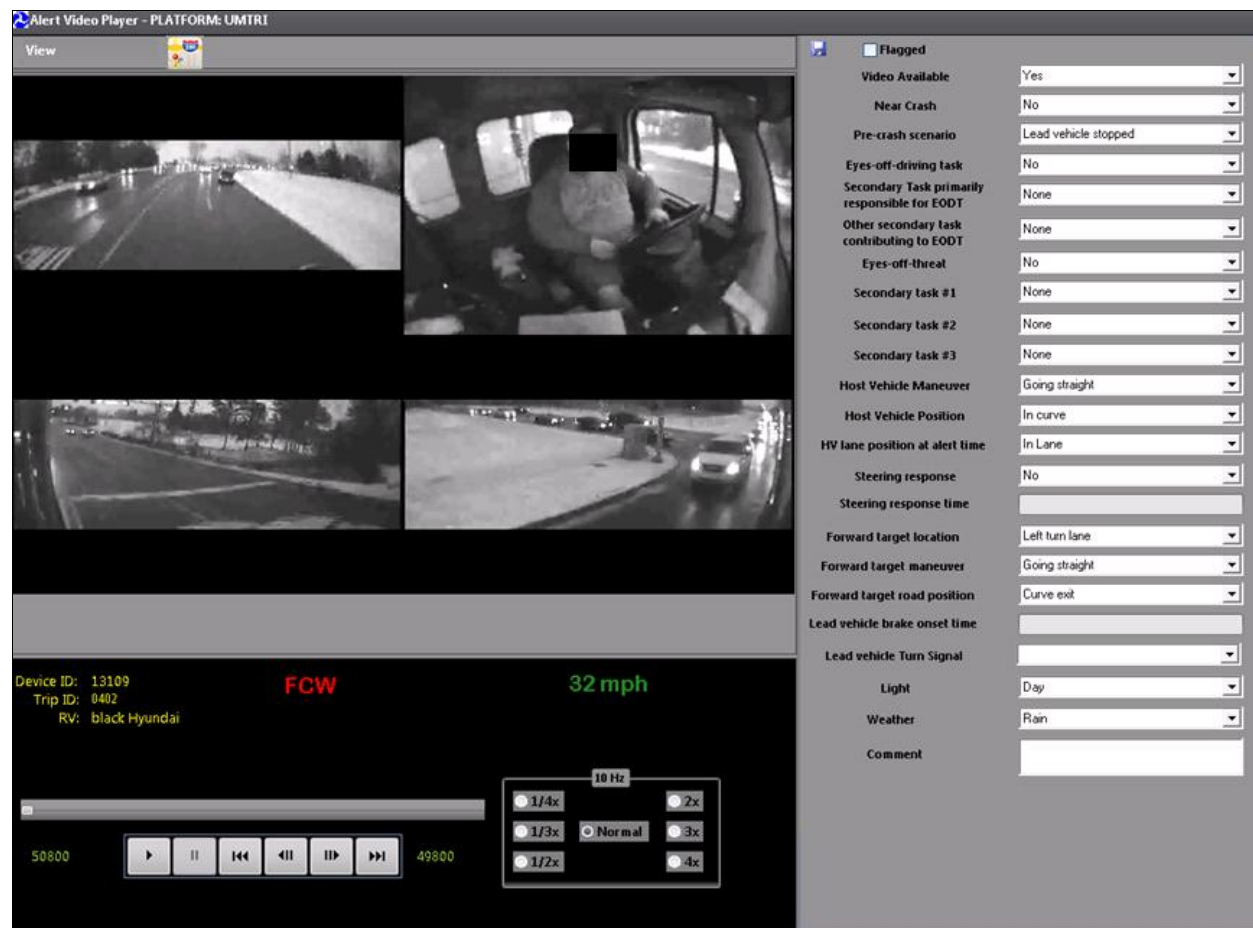
**Figure 6. Video Analysis Tool**

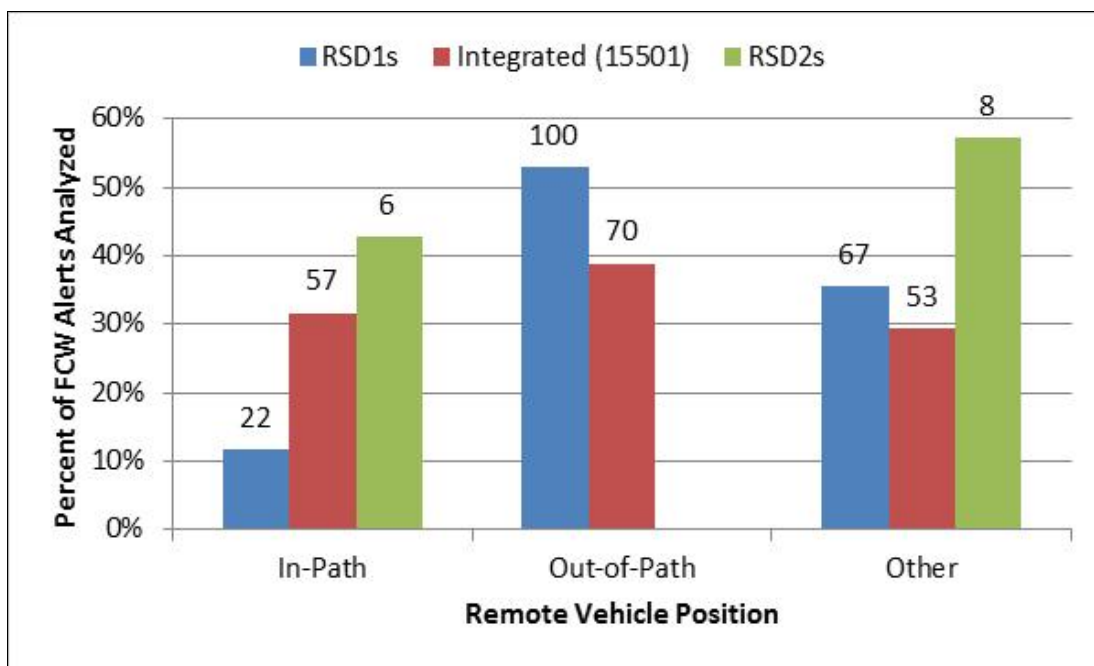
Figure 7. FCW Alerts by RV Position

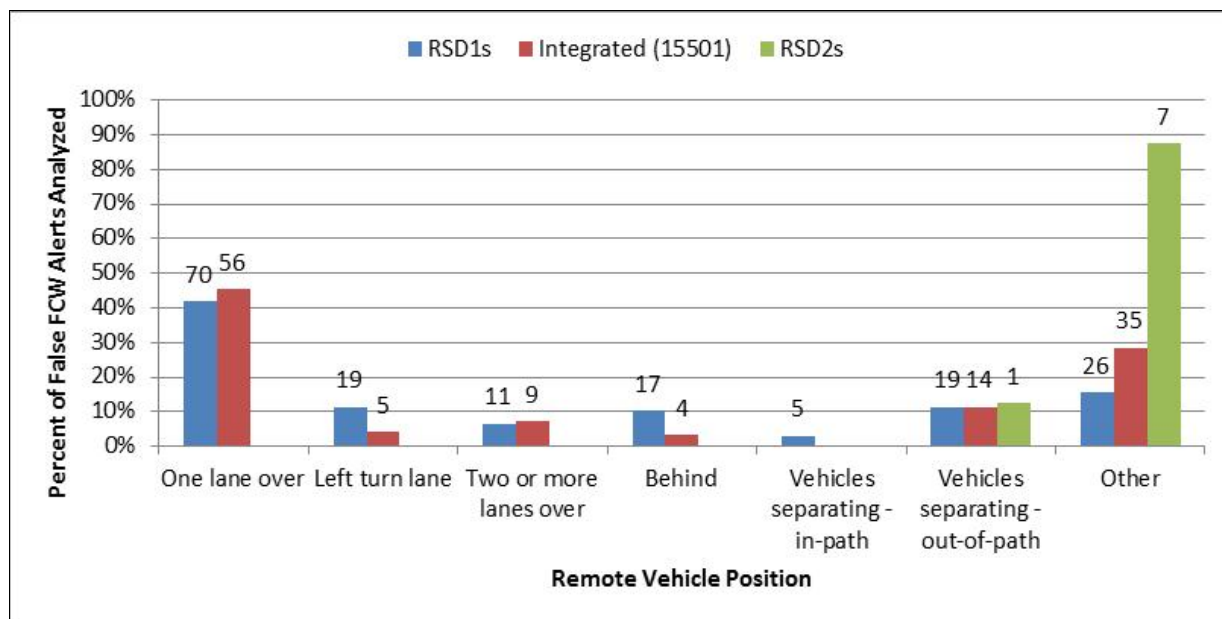
Figure 8 shows a detailed breakdown of the FCW false alert categories. The first three subcategories shown on the horizontal axis in Figure 8 are a breakdown of the “out-of-path” category, and the last four are a breakdown of the “Other” category.

Figure 8. Detailed Breakdown of False FCW Alerts by RV Position

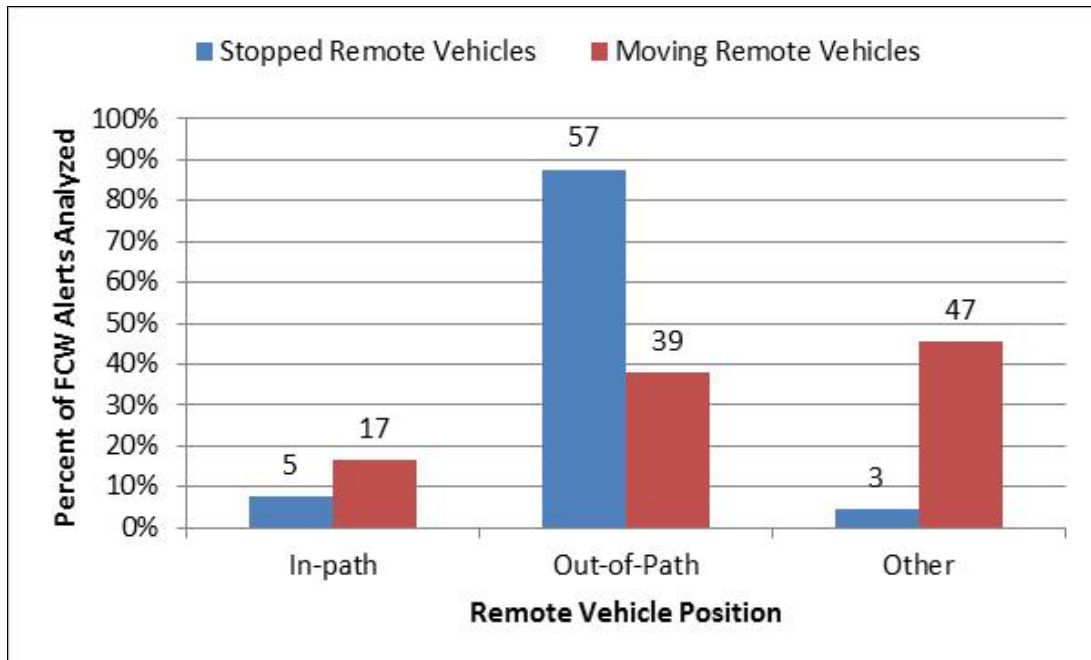
Figure 9. FCW RV Position by RV Motion – RSD1s

- The in-path percentage for stopped RVs was 8 percent for RSD1s (Figure 9).
- The in-path percentage for moving RVs was 17 percent (Figure 9).
- The in-path percentage for stopped RVs was 26 percent for the integrated truck (Figure 10).
- The in-path percentage for moving RVs was 41 percent (Figure 10).

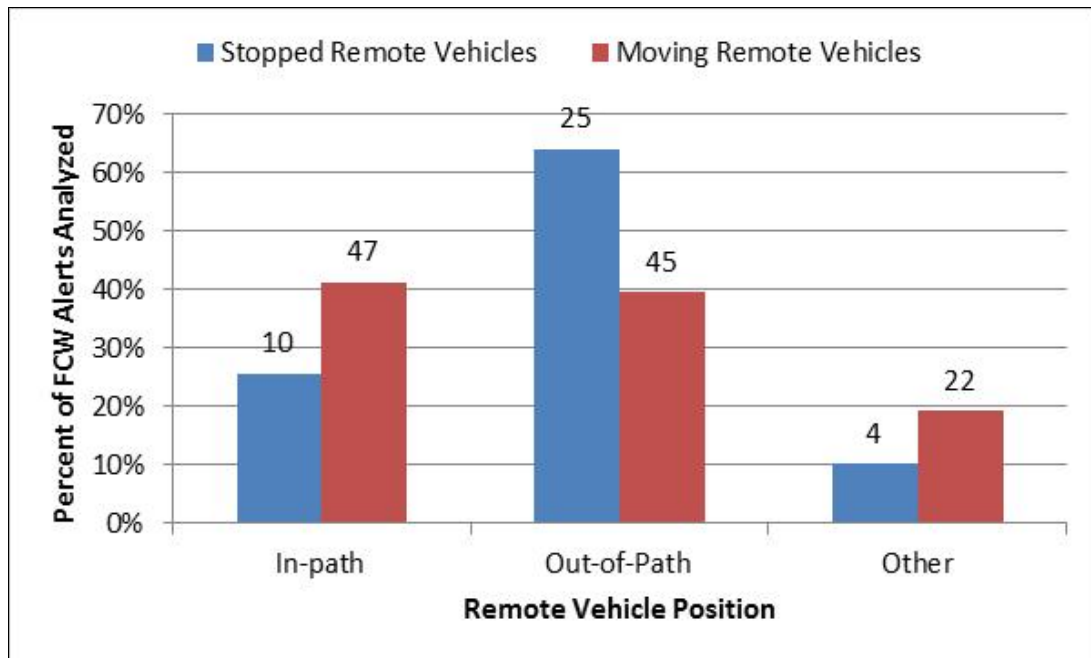
Figure 10. FCW RV Position by RV Motion – Integrated Truck #15501

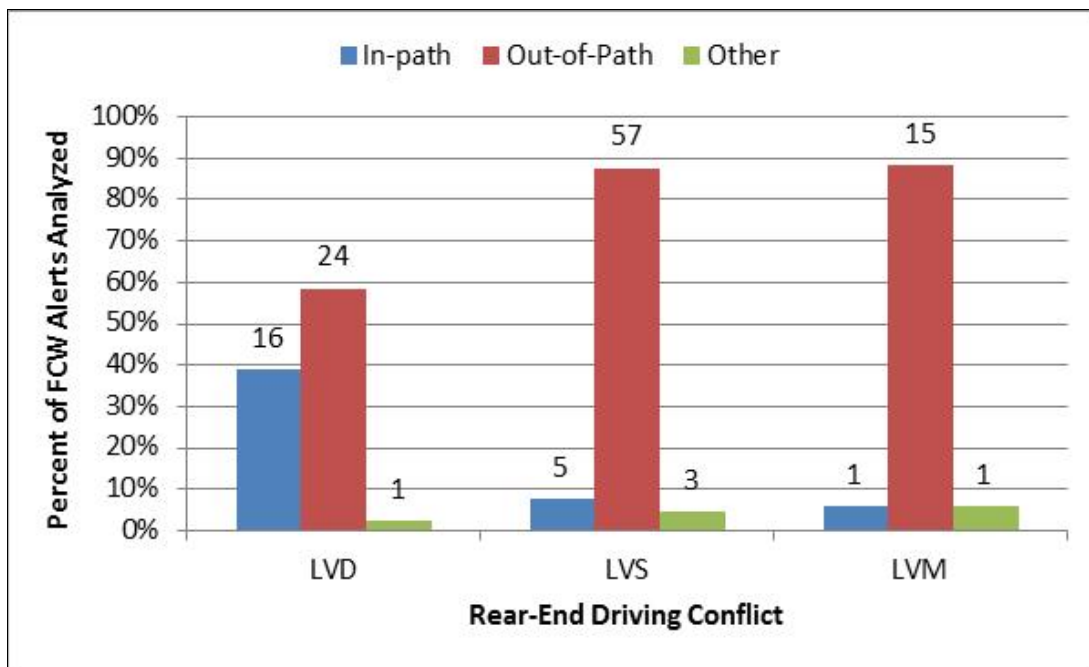
Figure 11. Rear-End Driving Conflict Type for FCW Alerts by RV Position – RSD1s

Figure 11 and Figure 12 show rear-end driving conflict type by FCW RV position for RSD1s and integrated truck #15501 respectively. It should be noted here that 66 FCW events extracted from the RSD1s contained unknown pre-crash scenarios and therefore, were not included in the analysis. As shown in Figure 11, the majority of the in-path alerts were issued during the LVD scenarios. Thirty-nine percent of the alerts issued during LVD scenarios were for in-path RVs. Figure 12 shows the same trend of in-path alerts across the rear-end conflict types as was observed in Figure 11. Fifty-seven percent of the alerts issued during LVD scenarios were for in-path RVs. Forty-five FCW events extracted from the integrated truck #15501 contained unknown pre-crash scenarios and therefore, were not included in the analysis.

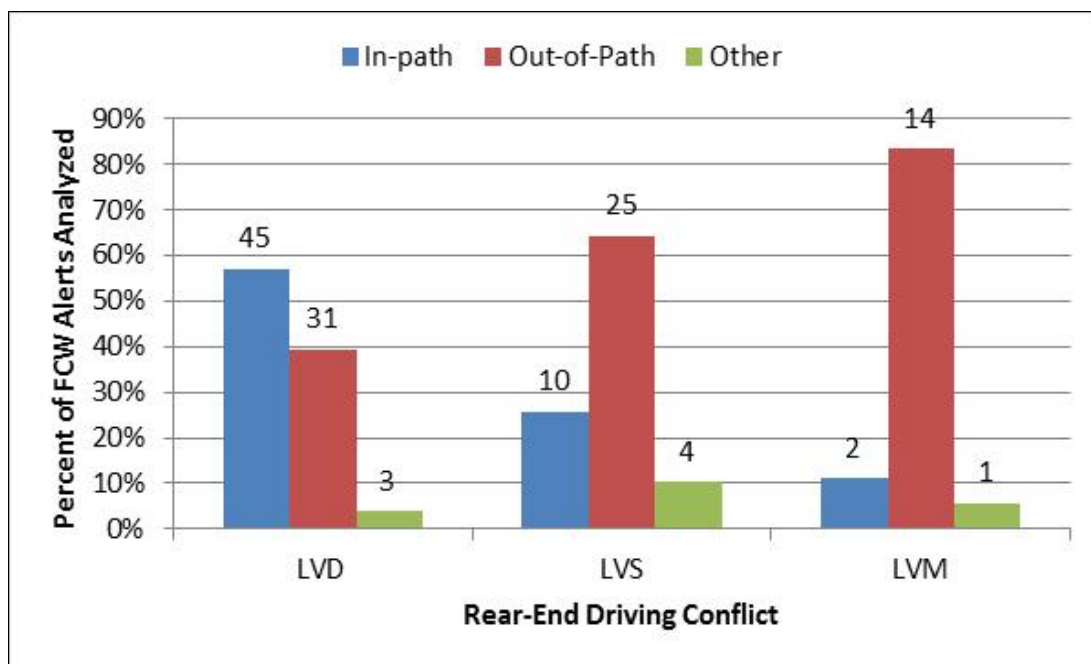
**Figure 12. Rear-End Driving Conflict Type for FCW Alerts by RV Position – Integrated Truck #15501**

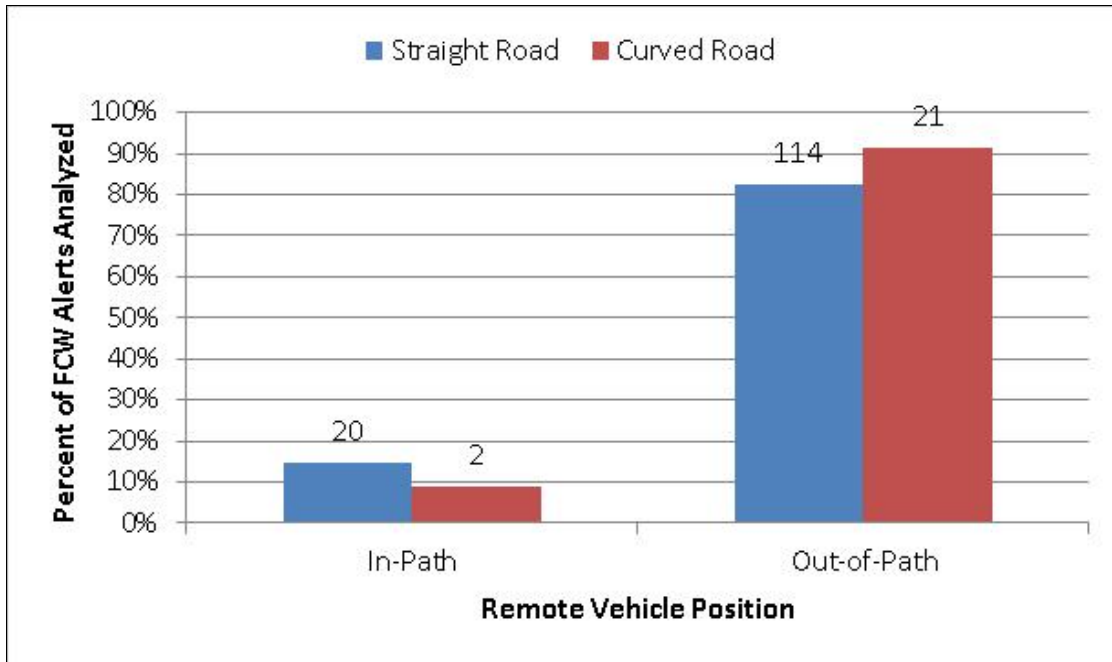
Figure 13. RV Position for FCW Alerts by Road Curvature (RSD1s)

Figure 13 and Figure 14 show the breakdown of FCW RV locations by road curvature for the RSD1s and the integrated truck #15501 respectively. It should be noted here that FCW events with unknown road curvature information (28 events for the RSD1s and 12 events for the integrated truck #15501) were not included in the analysis. Note that percentages for each field do not add up to 100 percent as the “other” field for RV location is not displayed. In scenarios where the RV could not be located or was not directly ahead on the same roadway, RV location within the curve is not recorded.

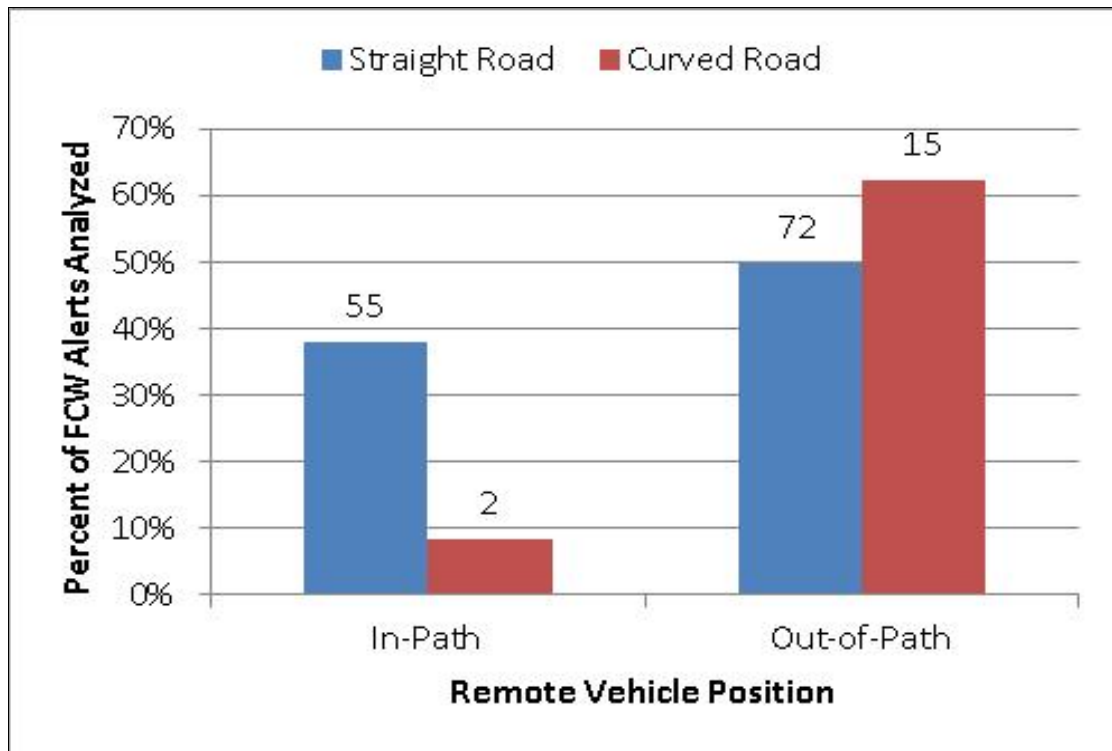
Figure 14. RV Position for FCW Alerts by Road Curvature (Integrated Truck #15501)

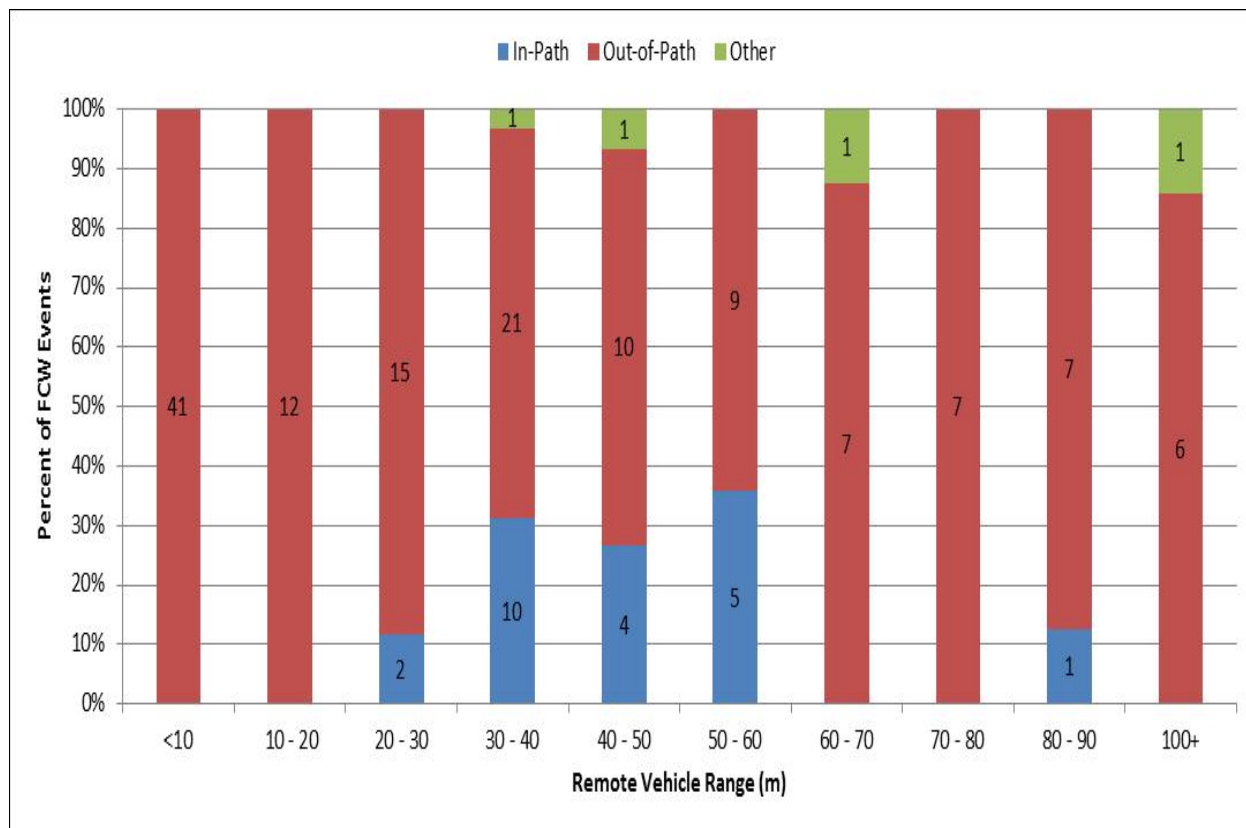
Figure 15. RV Position for FCW Alerts by RV Range (RSD1s)

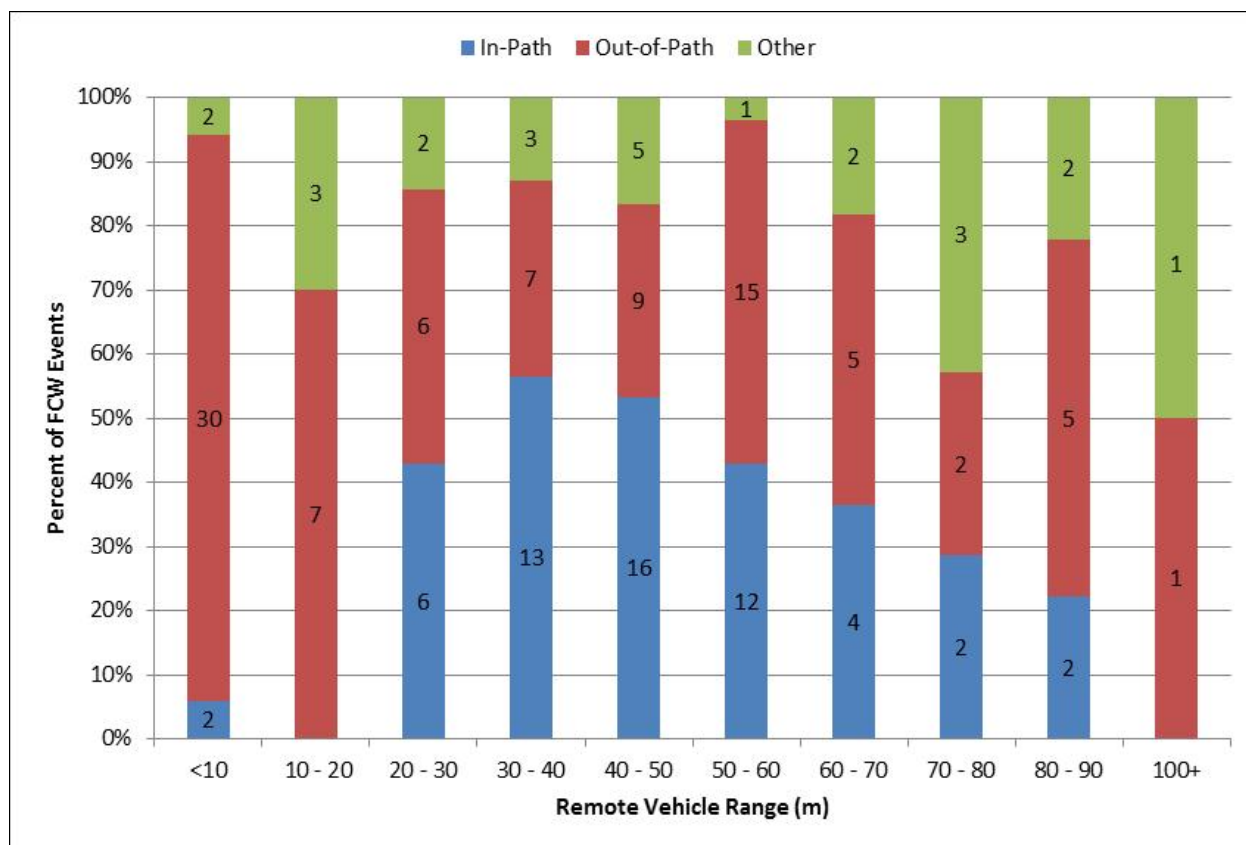
**Figure 16. RV Position for FCW Alerts by RV Range (Integrated Truck #15501)**

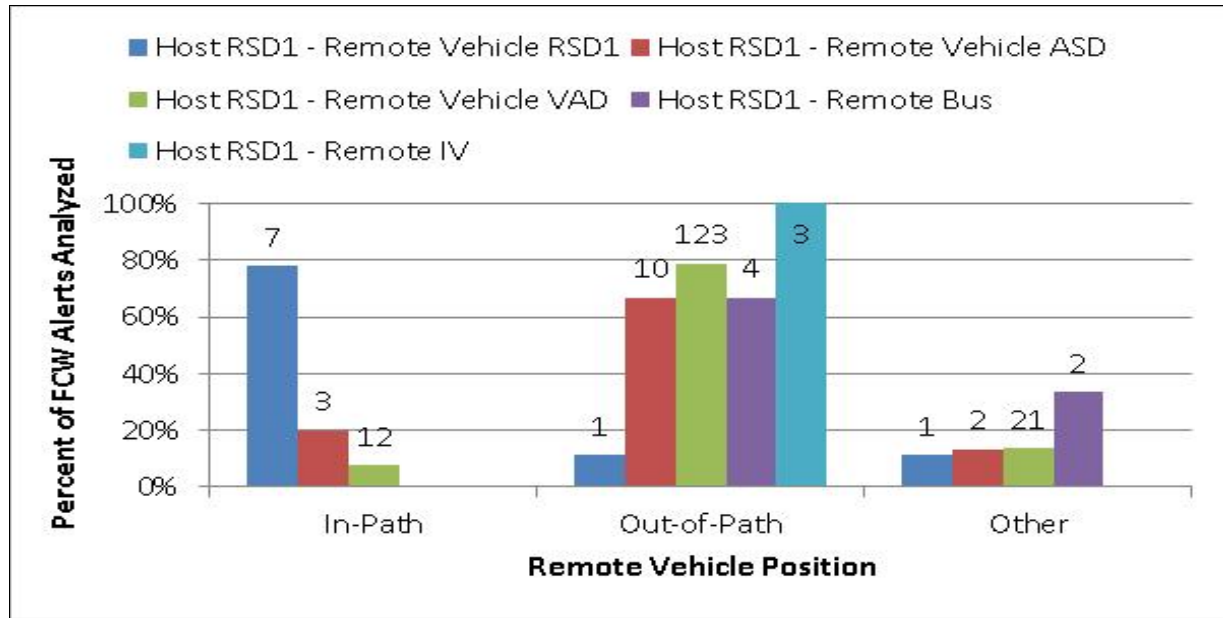
To understand the impact that various antenna configurations and devices have on the performance of the RSD1 and integrated truck #15501 FCW alerts, Figure 17 and Figure 18 break down the performance of RSD1 and integrated truck #15501 FCW alerts by other RV device types, respectively. As shown in Figure 17, nine of the RSD FCW alerts were triggered by other RSD1 equipped trucks with seven (78%) in-path alerts. Fifteen RSD FCW alerts were triggered by ASDs; three (20%) alerts were in-path while 156 alerts were triggered by VADs. Of these 156 alerts, 12 (8%) were in-path. In addition, there were six RSD FCW alerts triggered by buses and 3 FCW alerts triggered by IVs. Overall, there was a large disparity (78% compared to 9%) in percentages of in-path alerts triggered by RSD1 equipped trucks compared to in-path alerts triggered by ASDs and VADs combined.

**Figure 17. Breakdown of RSD1 FCW Alert Performance by RV Device Type**

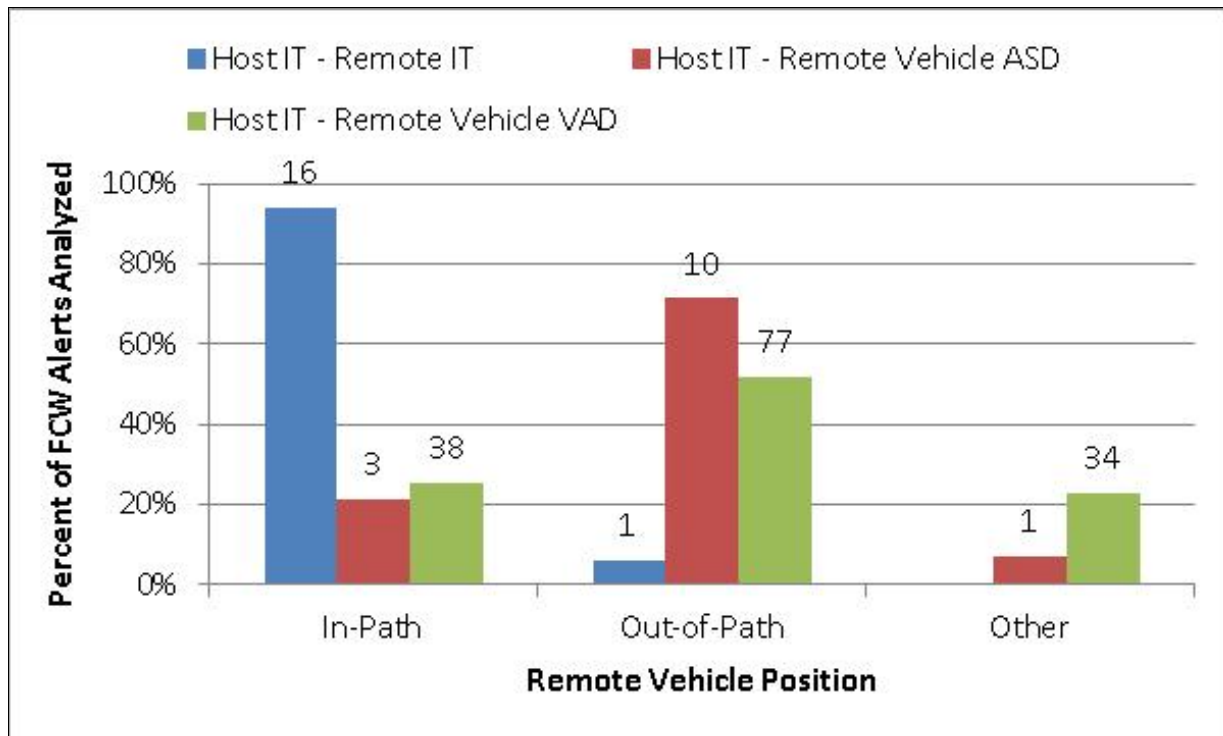
As shown in Figure 18, 17 of the integrated truck #15501 FCW alerts were triggered by other integrated trucks with 16 (94%) in-path alerts. Fourteen integrated truck #15501 FCW alerts were triggered by ASDs; 3 (21%) alerts were in-path while 149 alerts were triggered by VADs. Of these 149 alerts, 38 (26%) were in-path. The trends observed in Figure 18 are similar to those in Figure 17. Overall, there was a large disparity (94% compared to 25%) in percentages of in-path alerts triggered by remote integrated trucks compared to in-path alerts triggered by ASDs and VADs combined.

**Figure 18. Breakdown of Integrated Truck #15501 FCW Alert Performance by RV Device Type**

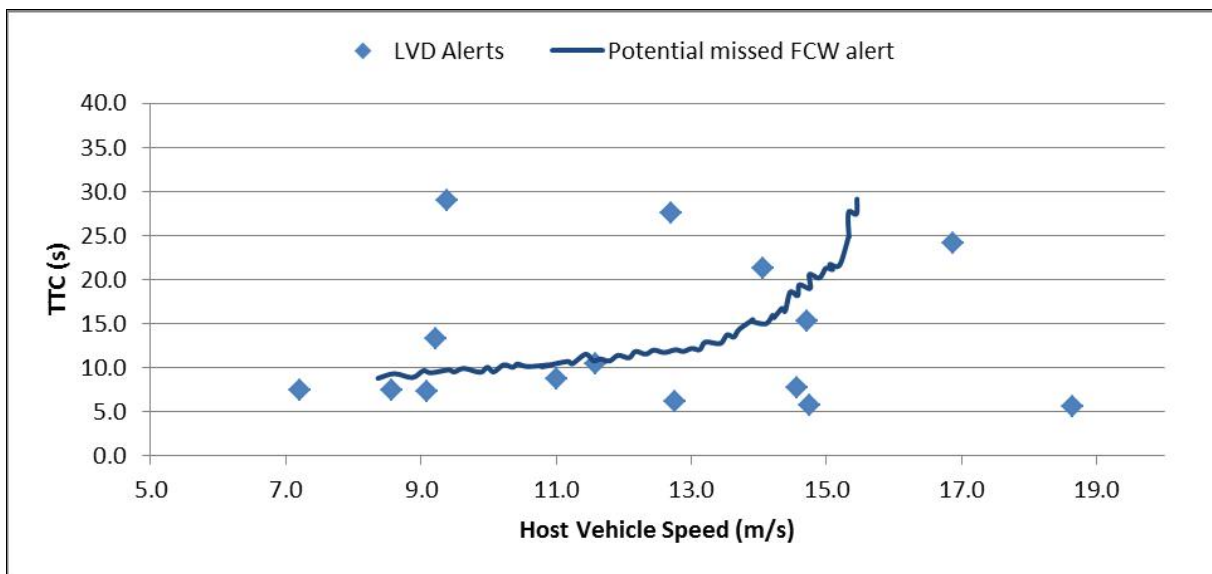
Figure 19 shows TTC versus HV speed for FCW alerts with decelerating RVs, as well as the TTC versus speed trajectory for the one potential missed FCW alert with decelerating RV. Figure 20 shows the same events but compares time headway to HV speed. Since LVD scenarios are triggered by deceleration, there is sometimes not a significant closing speed at the time of the event. Headway does not depend on closing speed and provides an alternative measure for the timing of the alert. Both comparisons showed that the trajectory of the vehicle dynamics in the missed alert scenario was consistent with the observed dynamics of the FCW alerts issued for decelerating RVs.

**Figure 19. Comparison of TTC for FCW Alerts and Potential Missed FCW Alert with Decelerating RVs – RSD1s**

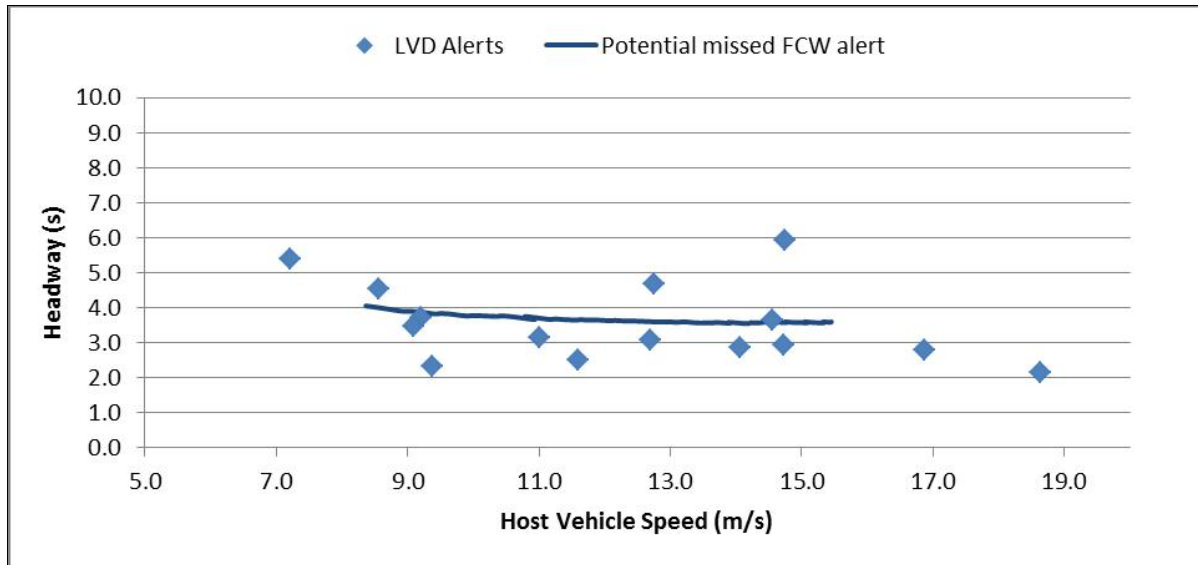
Figure 20. Comparison of Time Headway for FCW Alerts and Potential Missed FCW Alert With Decelerating RVs – RSD1s

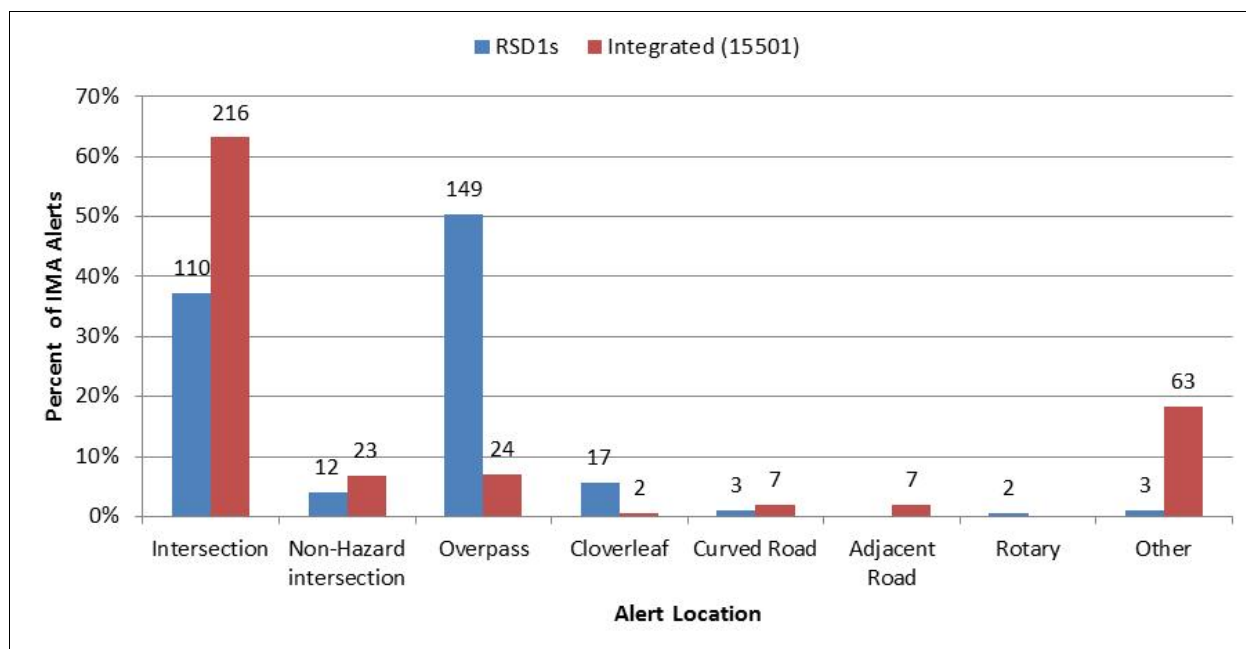
Figure 21 shows the overall breakdown of alert location for the IMA alerts issued by the integrated truck #15501 and the RSD1s. There were 638 IMA alerts issued by the integrated truck (342 alerts) and RSD1s (296 alerts). Table 8 provides definitions for the alert location categories listed in Figure 21. Table 8 also illustrates each category. In the diagrams, the green arrow represents the HV and the red arrow represents the RV. Any alert that did not fall into the “Intersection” category was considered a false alert. “Other” refers to events where an RV could not be identified (including events with no forward video), was off the roadway or not positioned appropriately for an IMA alert (e.g., in an adjacent parking lot, on a lateral roadway, or traveling the opposite direction).

Figure 21. Breakdown of IMA Warning Location by Device Type

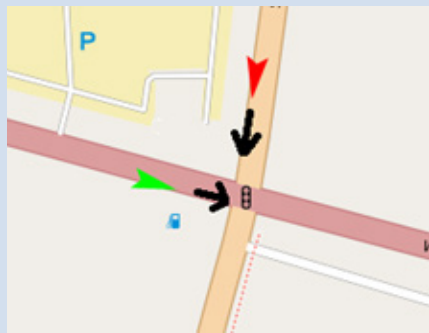
| Alert Location | Description |
|---|---|
| <b>Intersection</b><br> | Alert is issued while the HV is approaching, or stopped at an intersection, and in a potential hazard scenario (the paths of the HV and RV intersect). |

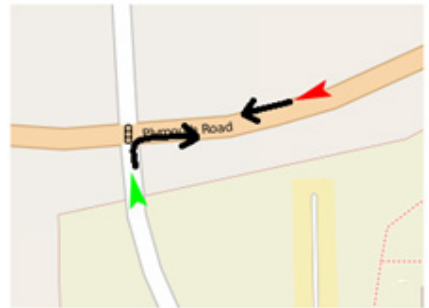
| Alert Location | Description |
|---|---|
| <b>Intersection, Non-Hazard</b><br> | Alert is issued while the HV is approaching, or stopped at an intersection. Due to the relative vehicle locations and paths of travel, the RV is not a threat. (Generally these are scenarios where the HV is making a right turn, and the RV is approaching from the right.) |

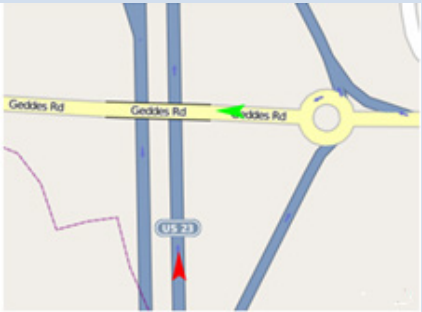
| Alert Location | Description |
|---|---|
| <p><b>Overpass</b></p> | <p>Alert is issued in a scenario where the paths of the HV and RV will not intersect because one path goes over an overpass.</p> |

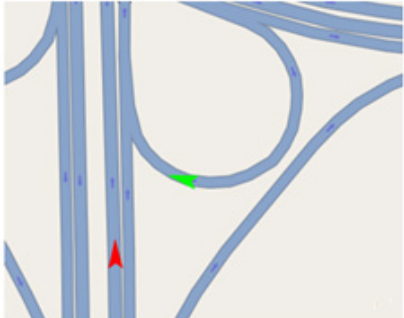
| Alert Location | Description |
|---|---|
| <p><b>Cloverleaf</b></p> | <p>Either the HV or RV<sup>13</sup> is traversing a cloverleaf at the time of the alert.</p> |

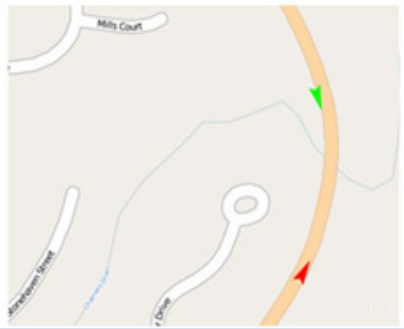
| Alert Location | Description |
|---|---|
| <p><b>Curved Road</b></p> | <p>The HV and the RV are approaching each other from opposite directions on a curved road.</p> |

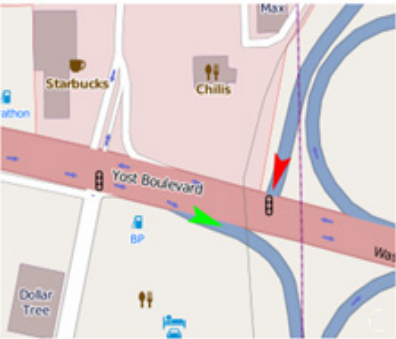
| Alert Location | Description |
|---|---|
| <p><b>Adjacent Road</b></p> | <p>The RV is on a road that does not intersect with the road the HV is on.</p> |

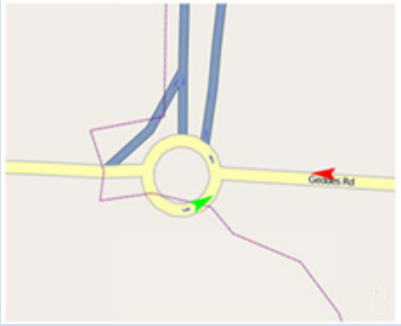
| Alert Location | Description |
|---|---|
| <b>Rotary</b><br> | <p>The HV is approaching, or navigating a rotary.</p> |

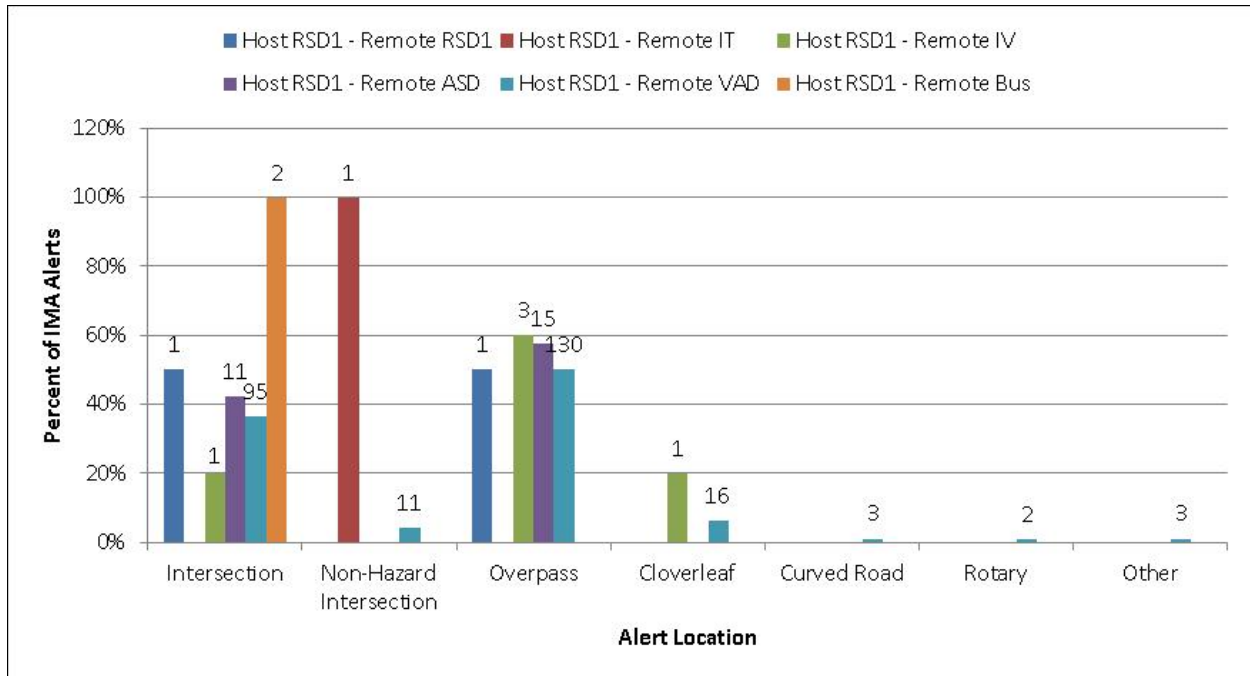
Figure 22 and Figure 23 break down the performance of RSD1 and integrated truck #15501 IMA alerts by other RV device types, respectively. As shown in Figure 22, the majority of the RSD1 IMA alerts issued at intersections were triggered by VADs and ASDs. There were 260 IMA alerts triggered by VADs with 95 (37%) alerts issued at intersections. Twenty-six RSD1 IMA alerts were triggered by ASDs; 11 (42%) alerts were issued at an intersection. The majority of the false alerts triggered by VADs (50%) and ASDs (58%) were issued at an overpass. Overall, the percentages of alerts triggered by VADs and ASDs at intersections, are approximately the same.

**Figure 22. Breakdown of RSD1 IMA Alert Performance by RV Device Type**

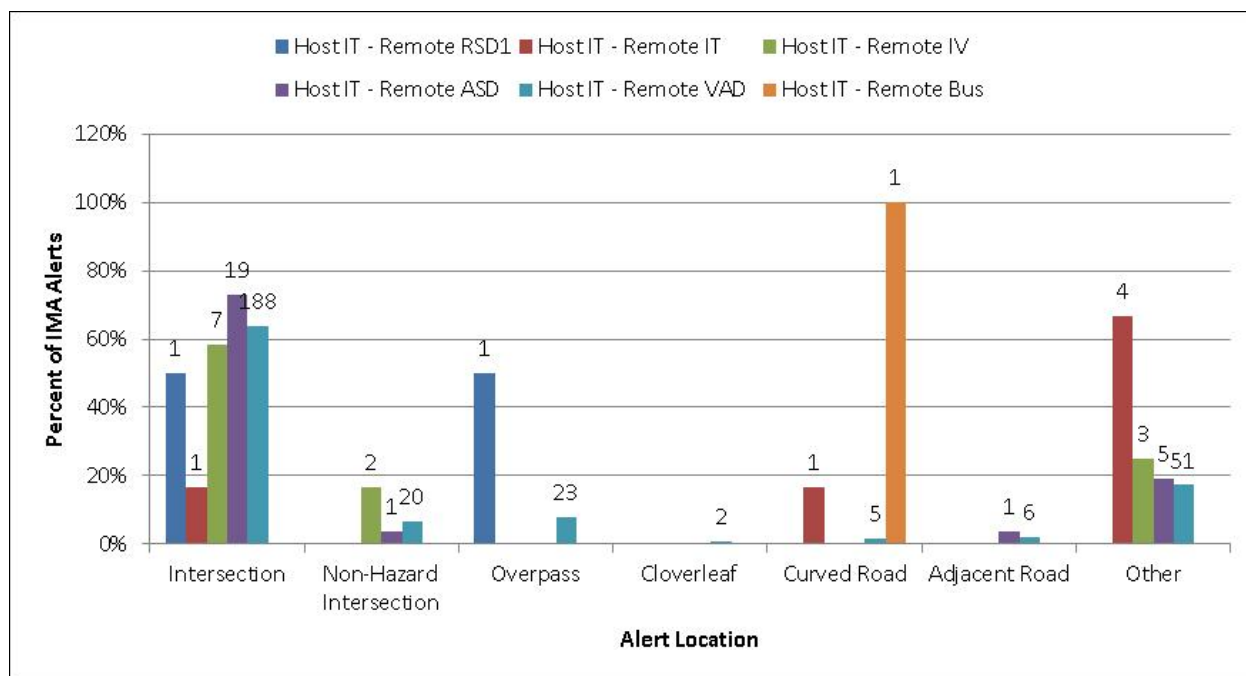
As was observed in Figure 22, the majority of the integrated truck #15501 IMA alerts (Figure 23) issued at intersections was triggered by VADs and ASDs. There were 295 integrated truck IMA alerts triggered by VADs with 188 (64%) alerts issued at intersections. Twenty-six IMA alerts were triggered by ASDs; 19 (73%) alerts were issued at an intersection. In addition, 12 IMA alerts were triggered by IVs; 7 (58%) alerts were issued at an intersection. There were fewer false alerts triggered at an overpass by the VADs compared to the totals shown in Figure 22. As stated previously, this could be attributed to the UMTRI drivers driving in areas where there were no overpasses. It could also be due to the integrated truck #15501 system accounting for elevation in GPS data. Overall, the percentages of alerts triggered by VADs and IVs at intersections, are approximately the same.

**Figure 23. Breakdown of Integrated Truck #15501 IMA Alert Performance by RV Device Type**

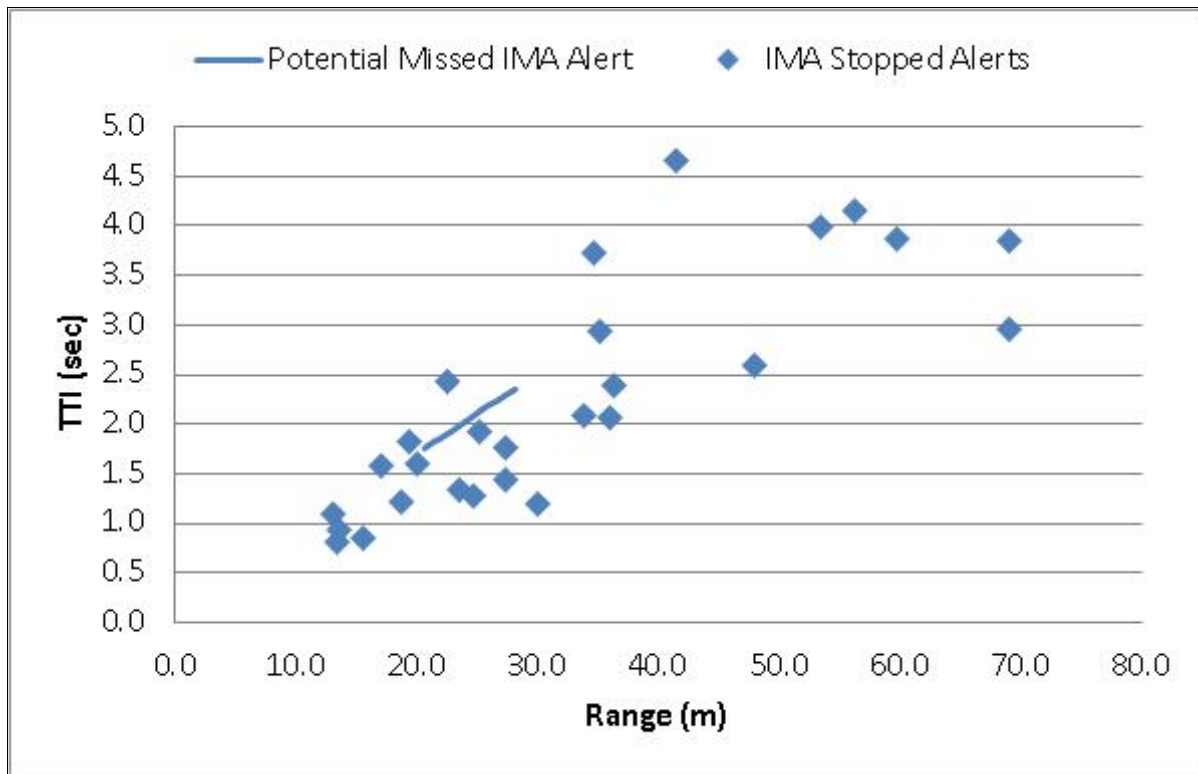
Figure 24 shows the RV's target time-to-intersection versus RV range at the onset of the IMA alerts, as well as the TTI versus range trajectory for the one potential missed IMA alert. The one potential missed alert event was within the range and TTI values observed in the IMA alerts.

Figure 24. Comparison of TTI for IMA Stopped Alerts and Potential Missed IMA Alert - RSD1s
