U.S. Department  
of Transportation  
**National Highway  
Traffic Safety  
Administration**

DOT HS 812 224

# **Independent Evaluation of Heavy-Truck Safety Applications Based on Vehicle-to-Vehicle and Vehicle-to-Infrastructure Communications Used in the Safety Pilot Model Deployment**

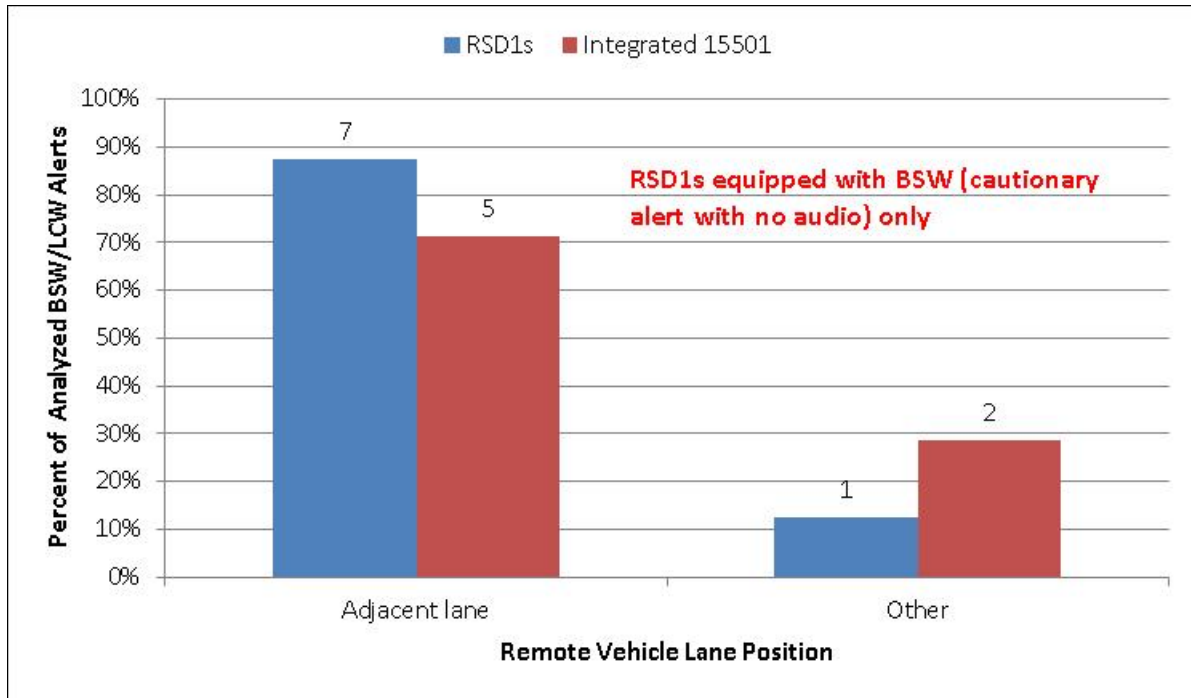
Figure 25. BSW/LCW RV Position

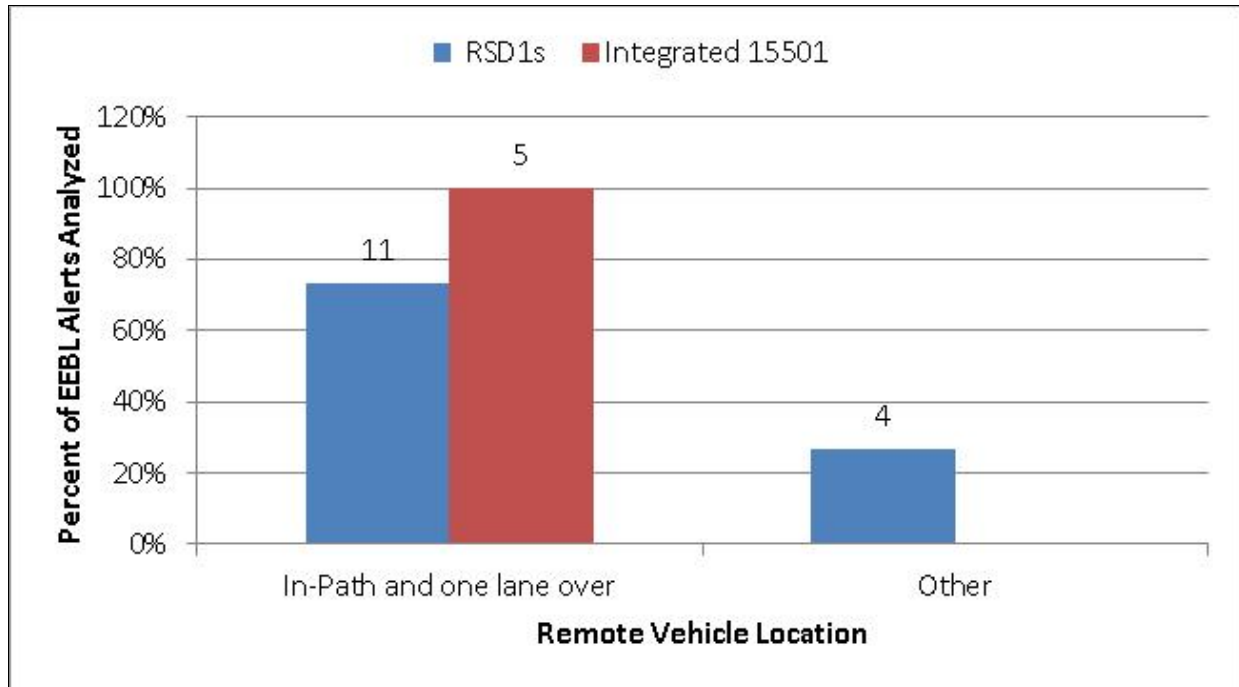
Figure 26. EEBL RV Position

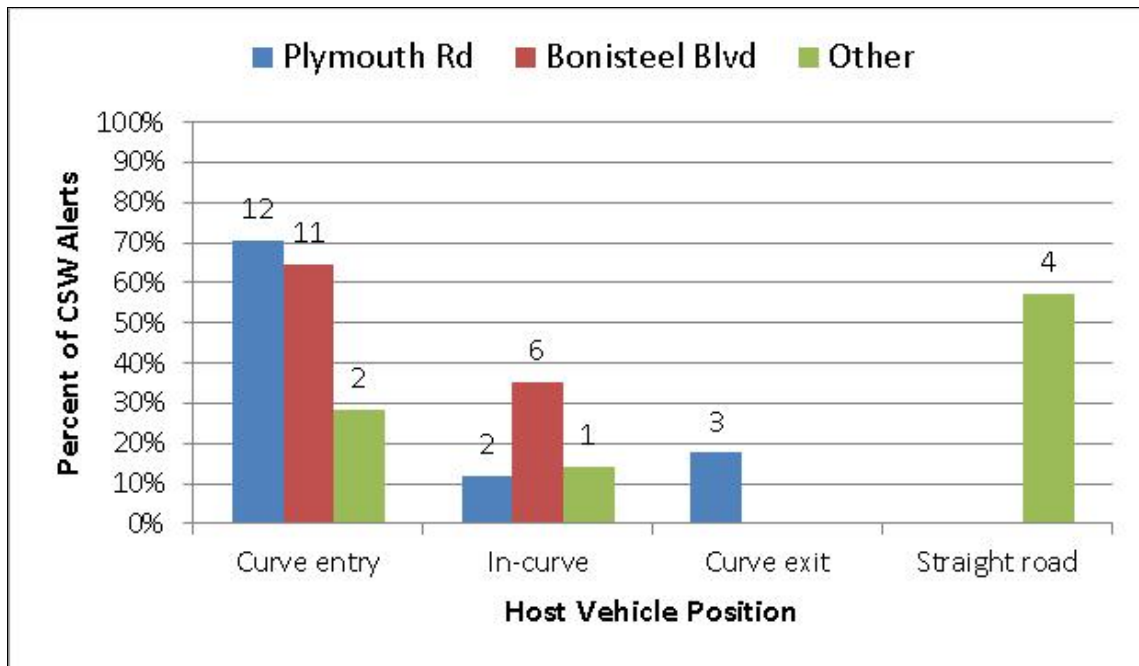
Figure 27. CSW HV Position

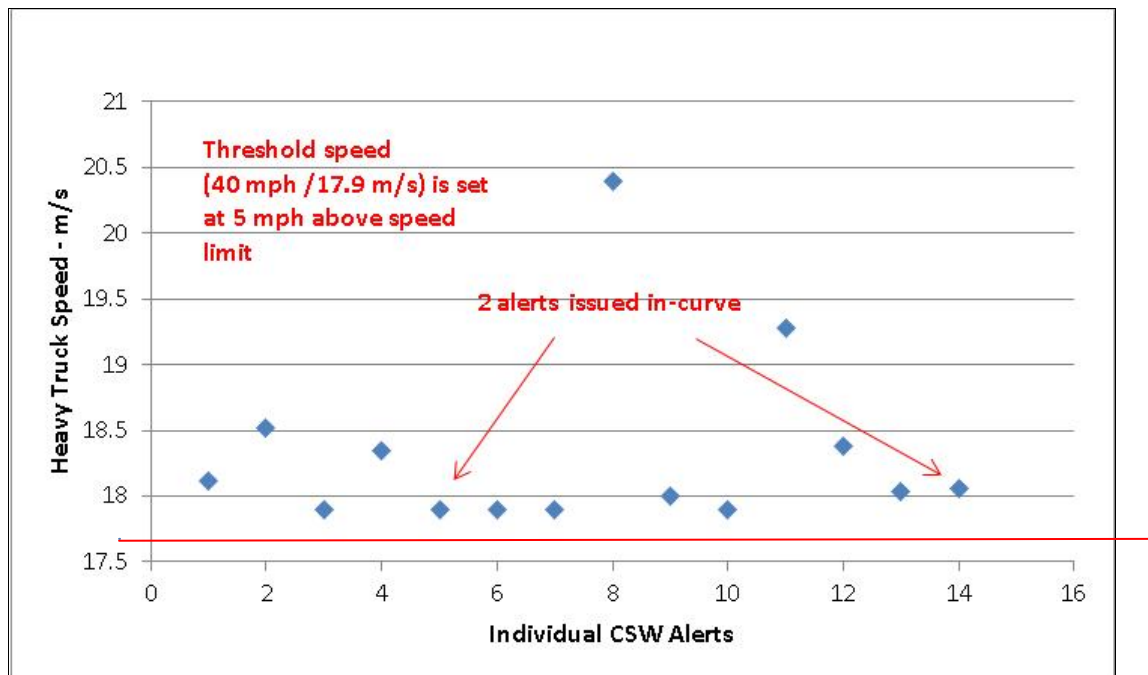
Figure 28. CSW Alerts Issued on Plymouth Road by HT Speed

Figure 28 and Figure 29 display the CSW alerts (curve entry and in-curve only) by vehicle speed at the Plymouth Road and Bonisteel Boulevard locations respectively. As shown in both figures all of the CSW alerts were issued at or above the threshold speeds. As shown in Figure 28, 2 of the 14 CSW alerts were issued in-curve. The remaining 12 alerts were issued at curve entry. It should be noted here that none of the CSW alert events involved the driver braking when the alert was issued. As shown in Figure 29, 6 of the 17 CSW alerts were issued in-curve. The remaining 11 alerts were issued at curve entry. None of the CSW alert events involved the driver braking when the alert was issued.

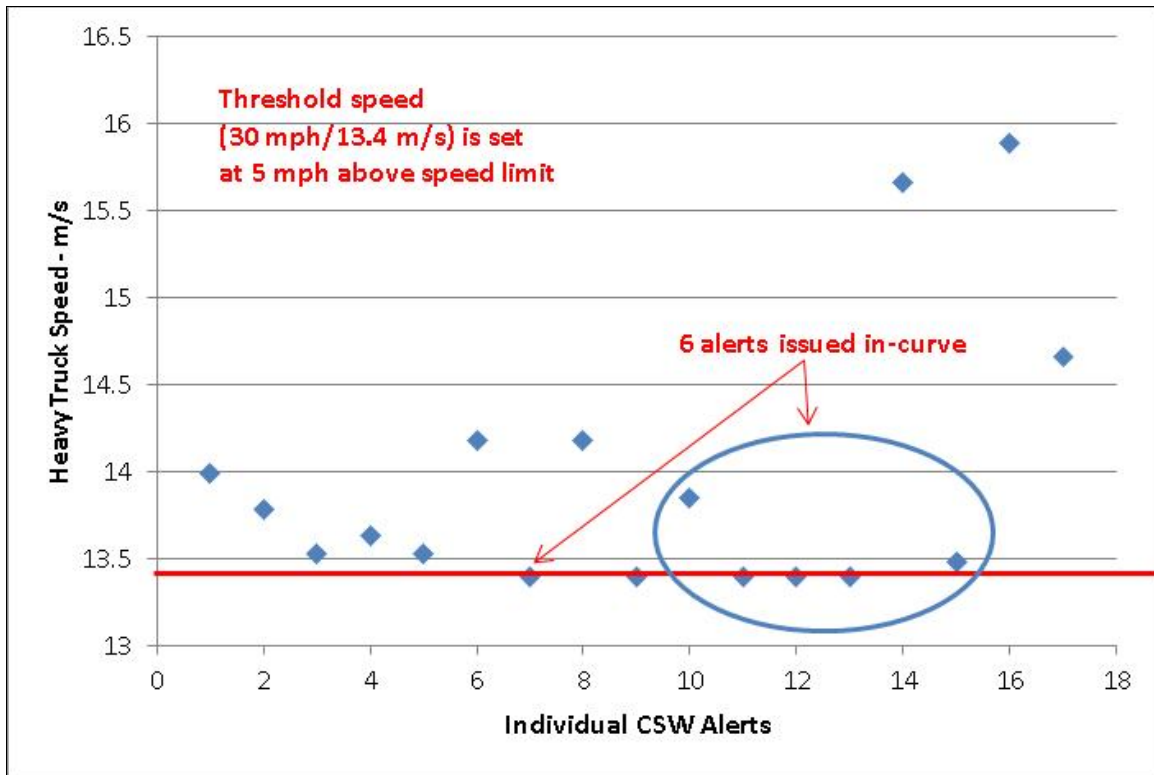
Figure 29. CSW Alerts Issued on Bonisteel Boulevard by HT Speed

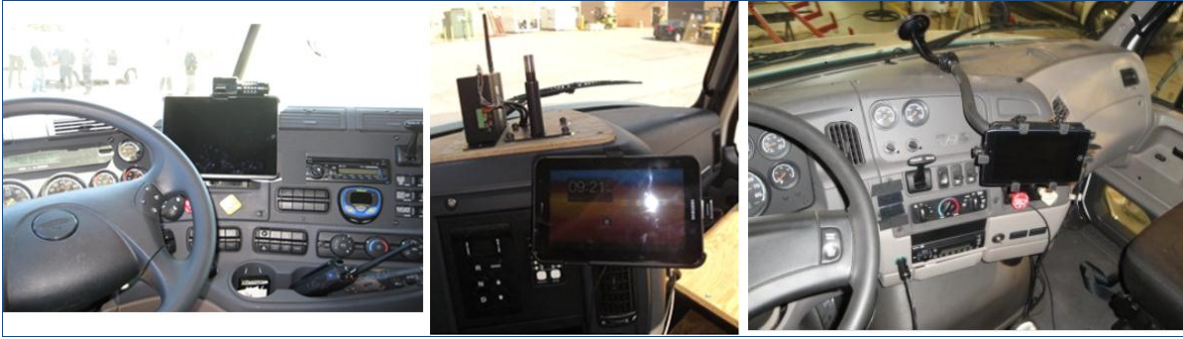
This section describes the DVIs used in the Integrated Trucks, and the RSD1 and RSD2 systems. The visual displays all consisted of a tablet mounted on the dashboard to the right of the driver (Figure 30).

**Figure 30. Placement of the Display Screen in the Integrated Truck (left), RSD1 (middle), and RSD2 (right)**
