# MONITORING AND EVALUATION OF THIN BONDED OVERLAYS AND SURFACE LAMINATES FOR BRIDGE DECKS

# Interim Report

## Monitoring and Evaluation of Thin Bonded Overlays and Surface Laminates for Bridge Decks

**August 1997**

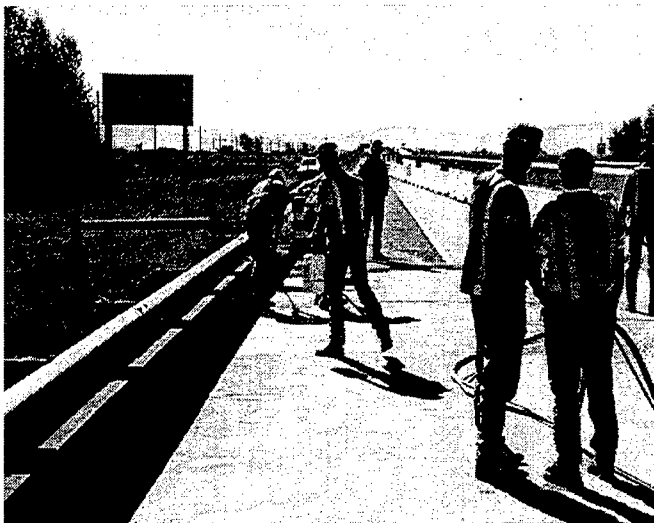
**Photo 3: Thorotop HCR installation, Gallatin River.**

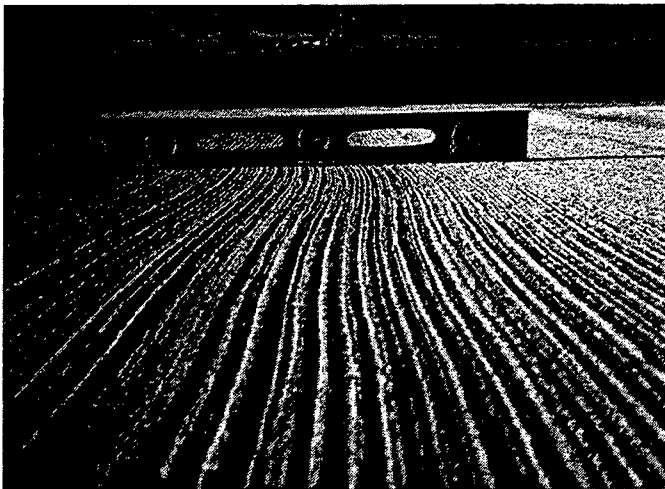
**Photo 7: Completed Thorotop HCR overlay, pre-traffic, West Garrison.**

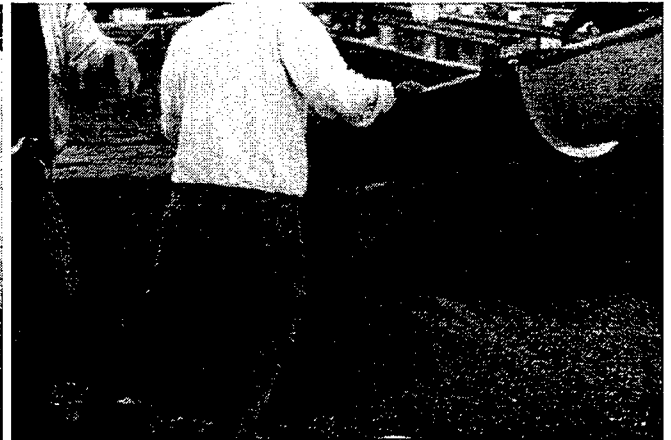
**Photo 9: Silica fume installation, Galen.**

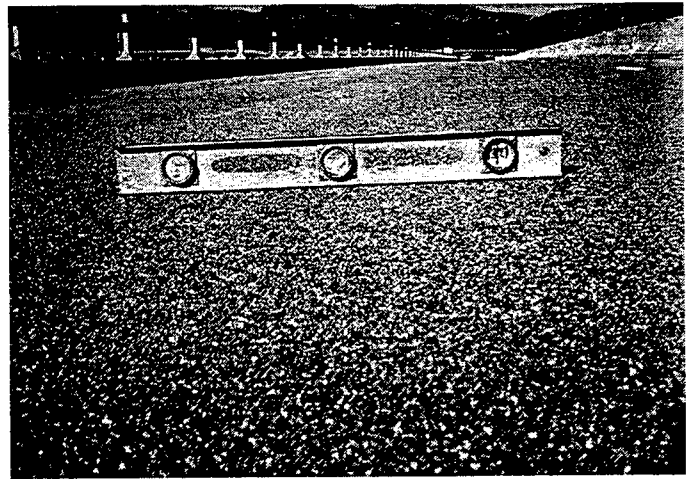
**Photo 17: Completed Flexolith 216 overlay, pre-traffic, East Garrison.**
