EVALUATION OF PREFABRICATED EDGE DRAINS (PED) IN OHIO

Final Report

Report No. UT-CE/GG 98-102

November, 1998

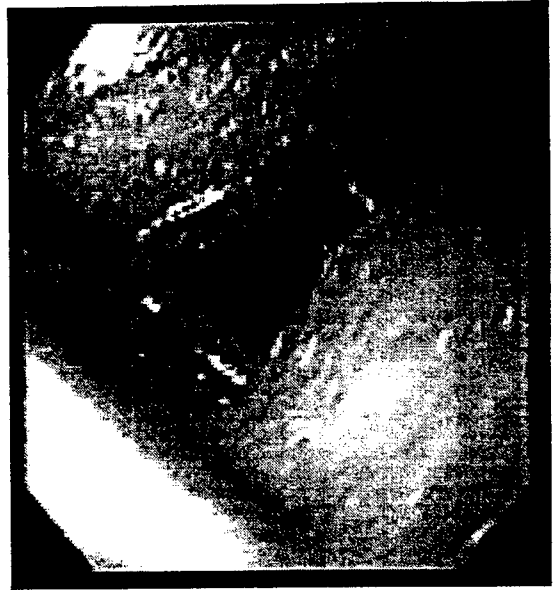
OTT(2) Run 3, Entering PED

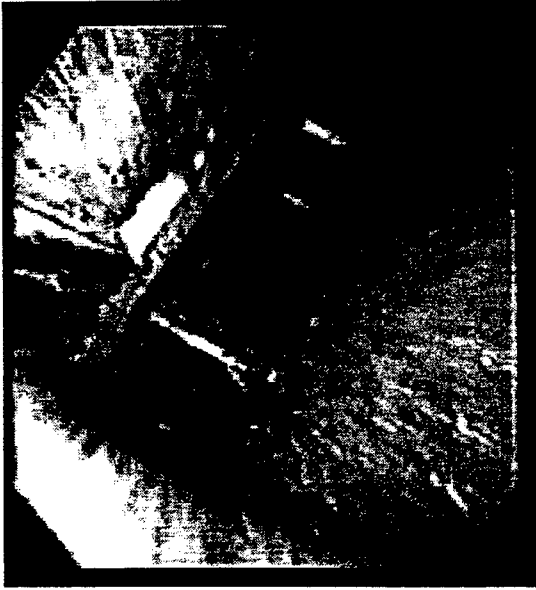
OTT(2) - Run 4, EOR PED Compression

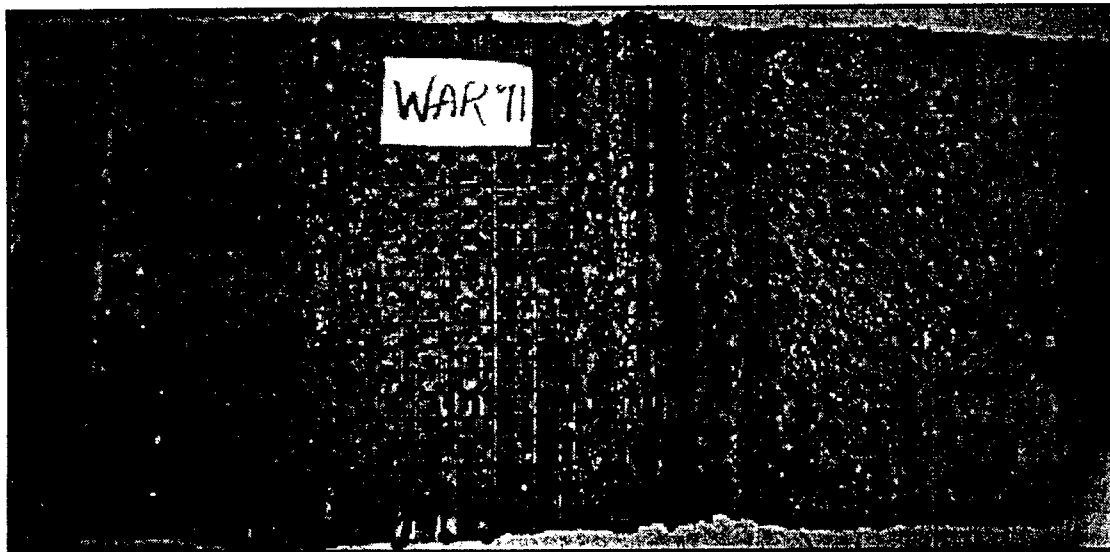
Figure 4.8 - PED Pictures, Warren County

Details on the visual and video borescope inspections are provided in Table 4.6. The PED was installed according to previous ODOT specifications. Monsanto Hydraway was the type of PED used. The PED had 6 inches of mud on the fabric and two inches inside the PED. (See Figure 4.8). Water flowed from the PED and filled the trench to a depth of 8 inches. The PED was crushed 4 inches near the bottom and 1 to 4 inches from the top. The fabric was compressed into the core.

a) PED Sample from Excavation

b) PED with Core Exposed
